## National Transportation Safety Board Aviation Accident Preliminary Report

<b>Location:</b>	Kalea, HI	<b>Accident Number:</b>	ANC22FA041
<b>Date &amp; Time:</b>	June 8, 2022, 17:26 Local	<b>Registration:</b>	N402SH
<b>Aircraft:</b>	Bell 407	<b>Injuries:</b>	3 Serious, 3 Minor
<b>Flight Conducted Under:</b>	Part 135: Air taxi & commuter - Non-scheduled - Sightseeing

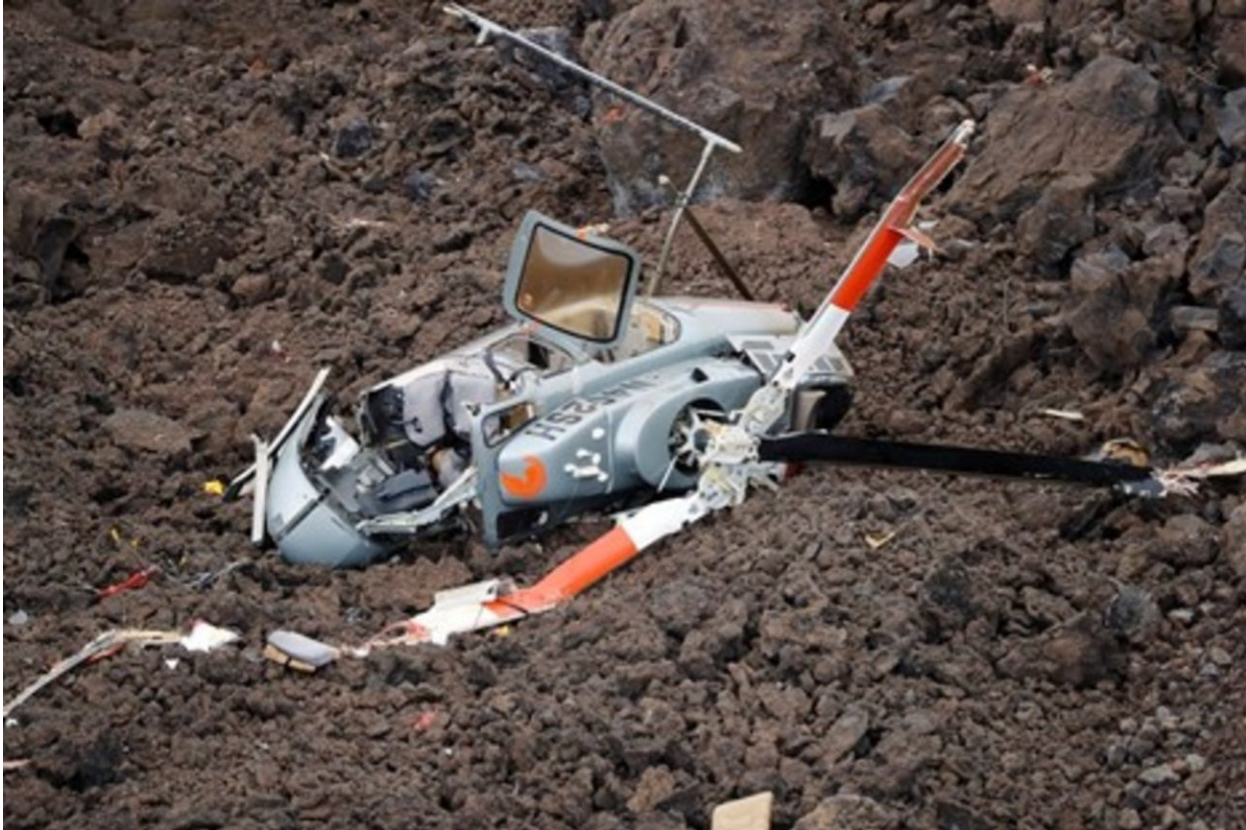
The helicopter continued to spin uncontrollably while it descended, and it subsequently struck an area of rough, uneven, lava-covered terrain and came to rest on its left side. (See Figure 1.)

Figure 1. Main wreckage in lava-covered terrain

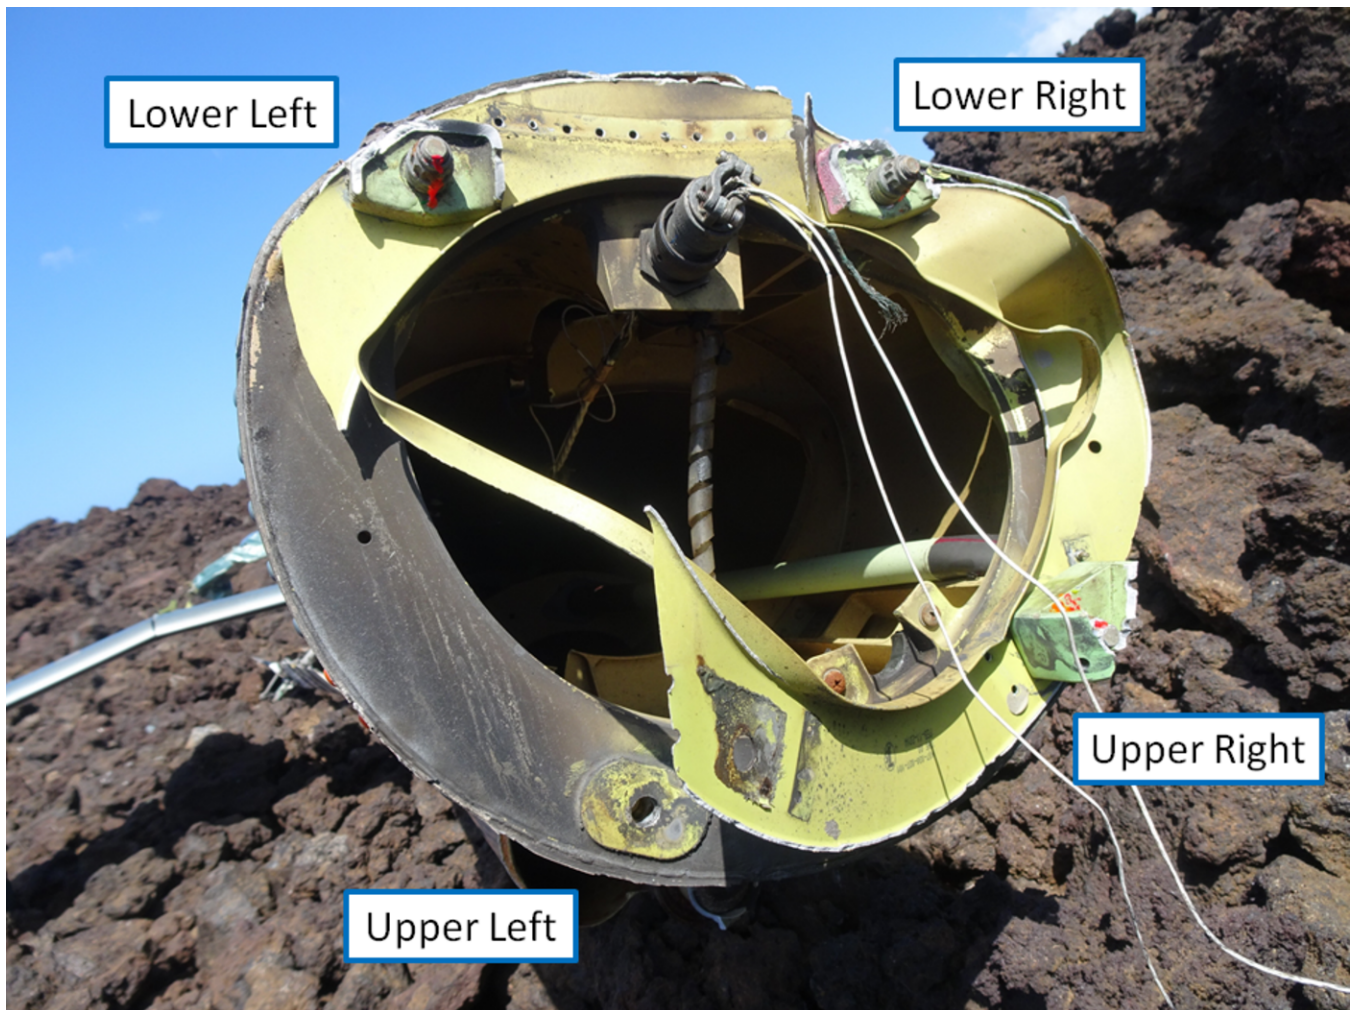
An NTSB on site examination of the accident site revealed the tail boom came to rest about 762 ft northeast from the main wreckage, which consisted of the fuselage, engine, and main rotor system. The tail boom separated from the fuselage at the tail boom attach point. (See Figure 2.) The upper left attachment fitting fastener was not present, and the lower left attachment fitting was fractured and displayed fatigue signatures. The fasteners for the lower left, lower right, and upper right attachment fittings were present.

Figure 2. Tail boom at accident site

A review of the accident helicopter's maintenance records revealed that the most recent tail boom attachment fasteners torque check (per Task #DMC-407-A-53-01-00-00A-72A) was completed on May 4, 2022, at a total airframe time of 22,891.4 flight hours. At the time of the accident, the helicopter had accumulated 23,005.6 flight hours (114.2 flight hours since the torque check), and no additional maintenance had been conducted to that attachment location.
