# Aviation Investigation Final Report

<b>Location:</b>	Fort Collins, Colorado	<b>Accident Number:</b>	CEN22LA414
<b>Date &amp; Time:</b>	September 11, 2022, 18:59 Local	<b>Registration:</b>	N9049H
<b>Aircraft:</b>	Cessna 172M	<b>Aircraft Damage:</b>	Substantial
<b>Defining Event:</b>	Collision with terr/obj (non-CFIT)	<b>Injuries:</b>	2 Minor
<b>Flight Conducted Under:</b>	Part 91: General aviation - Personal

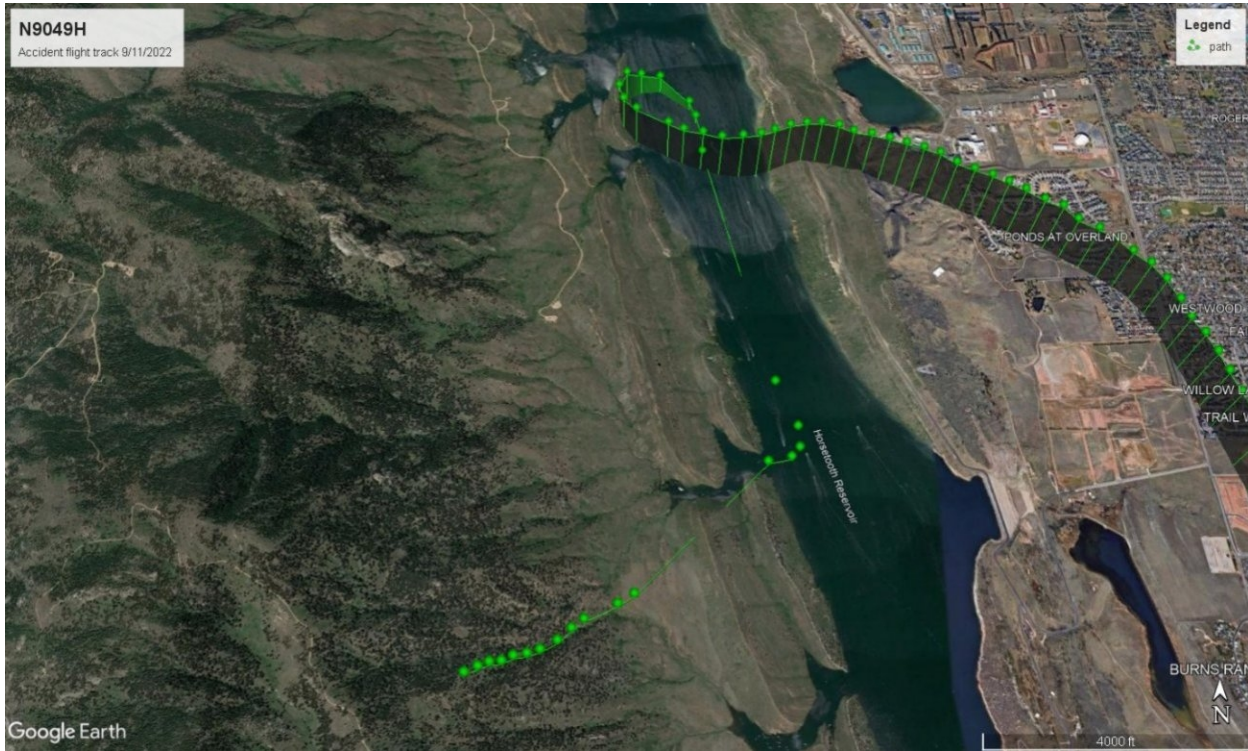
Flight track data for this report was obtained from L3/Harris OpsVue, a commercially available web base product that aggregates and georeferences Federal Aviation Administration (FAA) data sources including data from FAA ASDE-X and ASSC systems, FAA terminal and en route radars, the FAA certified ADS-B Network and flight plan data from the En Route Automation Modernization (ERAM) system. The accident airplane was squawking a non-discreet beacon code of 1200 and positive identification could not be made. However, the flight track data obtained was consistent with the reported departure time and airport, and the flight track ended near the recorded accident location (figure 1). A review of the data revealed that the airplane was about 6,550 ft above mean sea level (msl) when it crossed the east bank of the reservoir headed west. After it crossed about mid-channel, the airplane turned right, about 270°

while descending to an altitude below 5,500 ft msl (floor of coverage). Due to being below the floor of coverage, flight track and altitudes ceased to record. When the airplane was reacquired, the position was about 1 mile south at an altitude of about 5,375 ft msl. The airplane traversed about 1.6 miles south along the reservoir before it turned west and climbed. The last recorded altitude was about 6,075 ft msl near the accident location.

Figure 1: Flight track

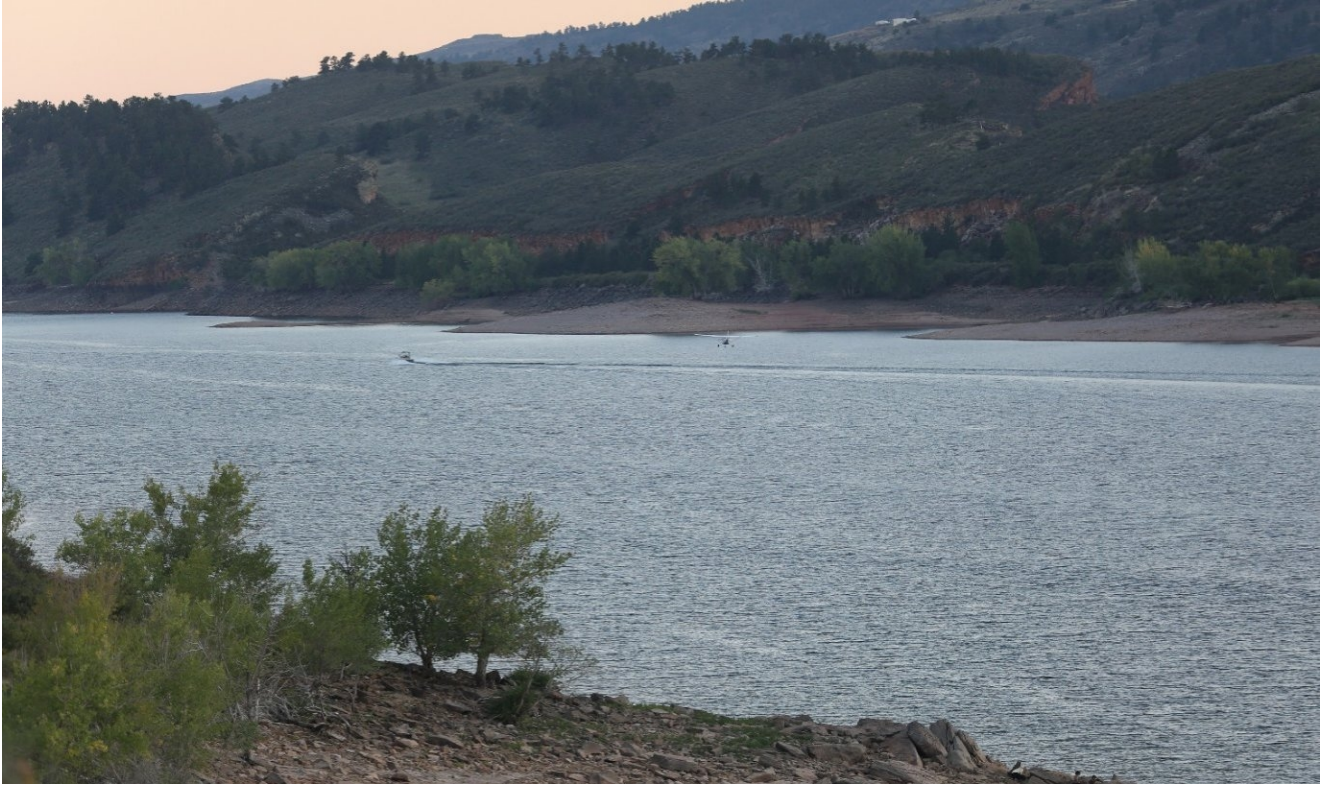
Photographs provided by a witness show the airplane low over the water as it approached one of only three visible boats. At first, the airplane appeared headed toward the shore, but made a left turn toward the first boat (figures 2 and 3). After making a very low pass over the boat (figure 4), the airplane made a steep climb, followed by a steep right turn (figure 5), and then low over the second boat (figure 6). After passing the second boat, the airplane appeared to depart toward a valley.

*Figure 2: Airplane over the reservoir (Courtesy of a witness)*

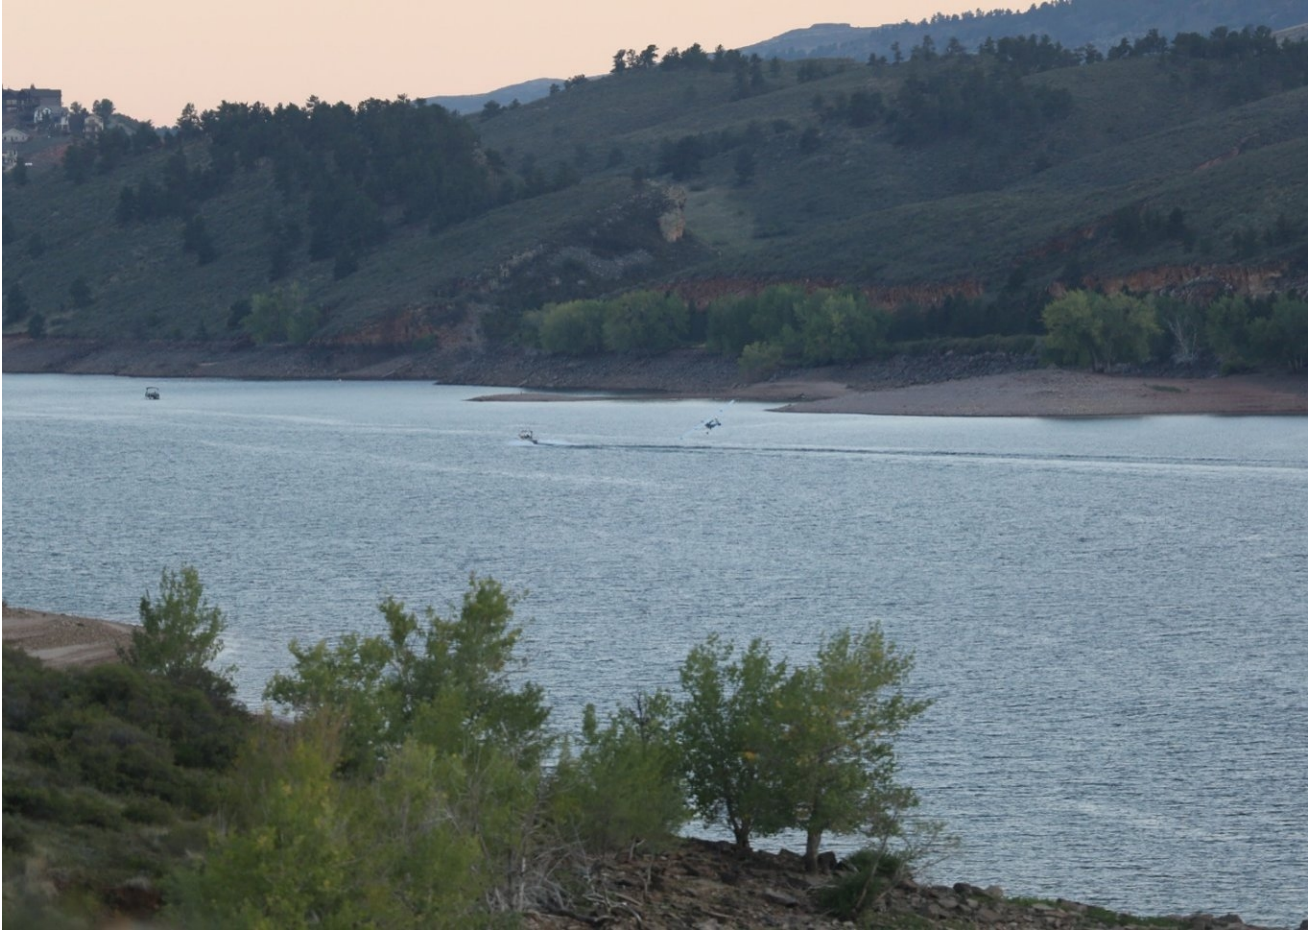
Figure 3: Airplane bank toward a boat (Source: a witness)

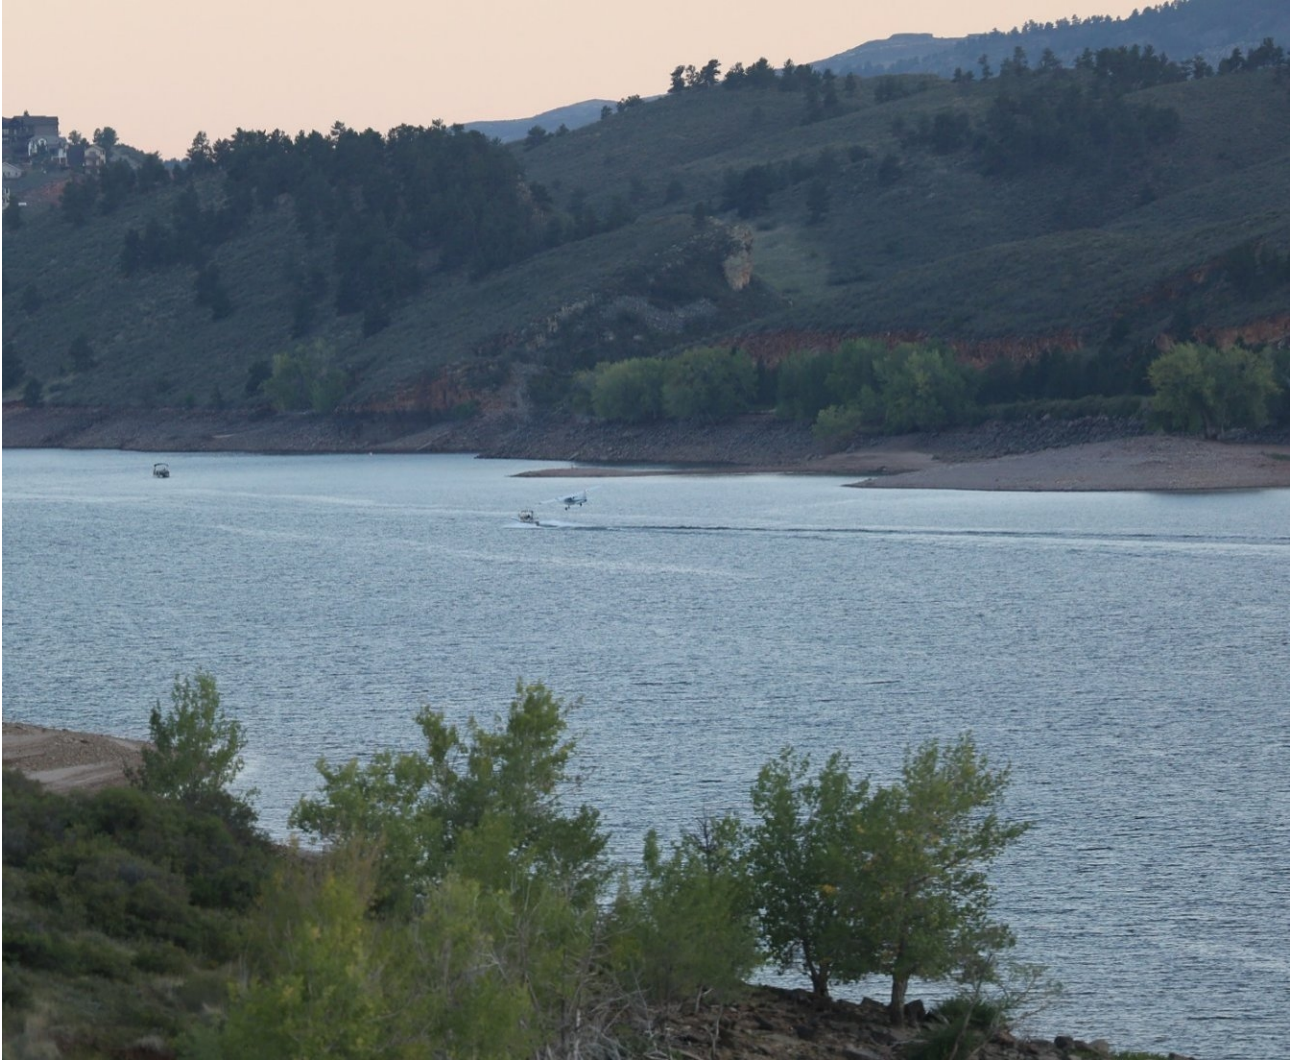
Figure 4: Airplane approaching the first boat (Source: a witness)

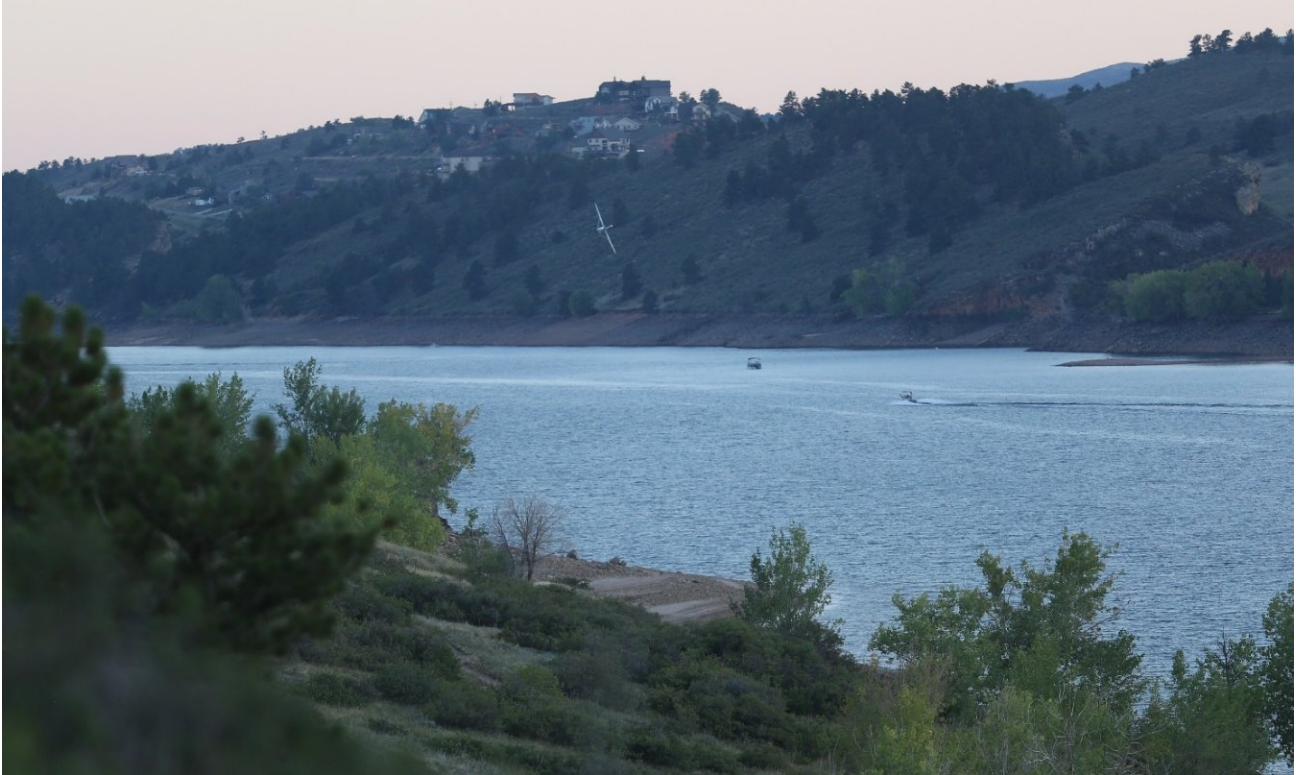
Figure 5: Airplane passing the first boat in a steep right turn (Source: a witness)

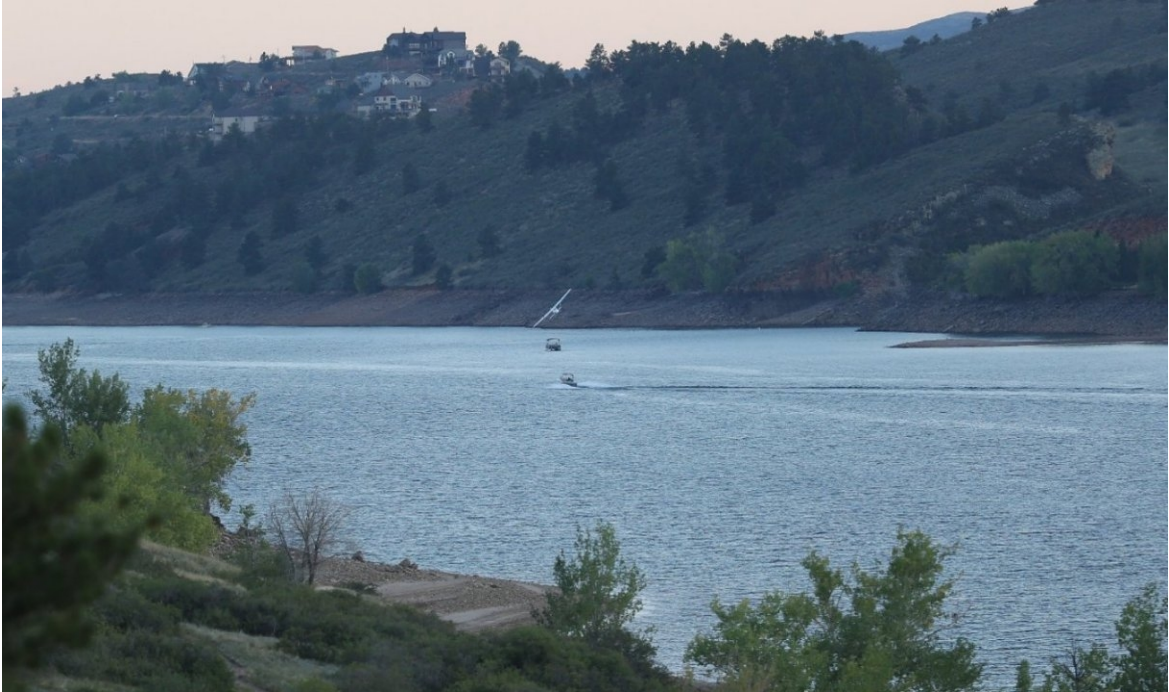
Figure 6: Approaching the second boat in a left turn (Source: a witness)
