# Aviation Investigation Preliminary Report

<b>Location:</b>	Chicago, IL	<b>Occurrence Number:</b>	DCA25LA141
<b>Date &amp; Time:</b>	February 25, 2025, 08:48 Local	<b>Registration:</b>	N8517F (A1); N560FX (A2)
<b>Aircraft:</b>	Boeing 737-800 (A1); Bombardier BD-100-1A10 (CL-35) (A2)	<b>Injuries:</b>	142 None (A1); 3 None (A2)
<b>Flight Conducted Under:</b>	Part 121: Air carrier - Scheduled (A1); Part 91 subpart k: Fractional (A2)

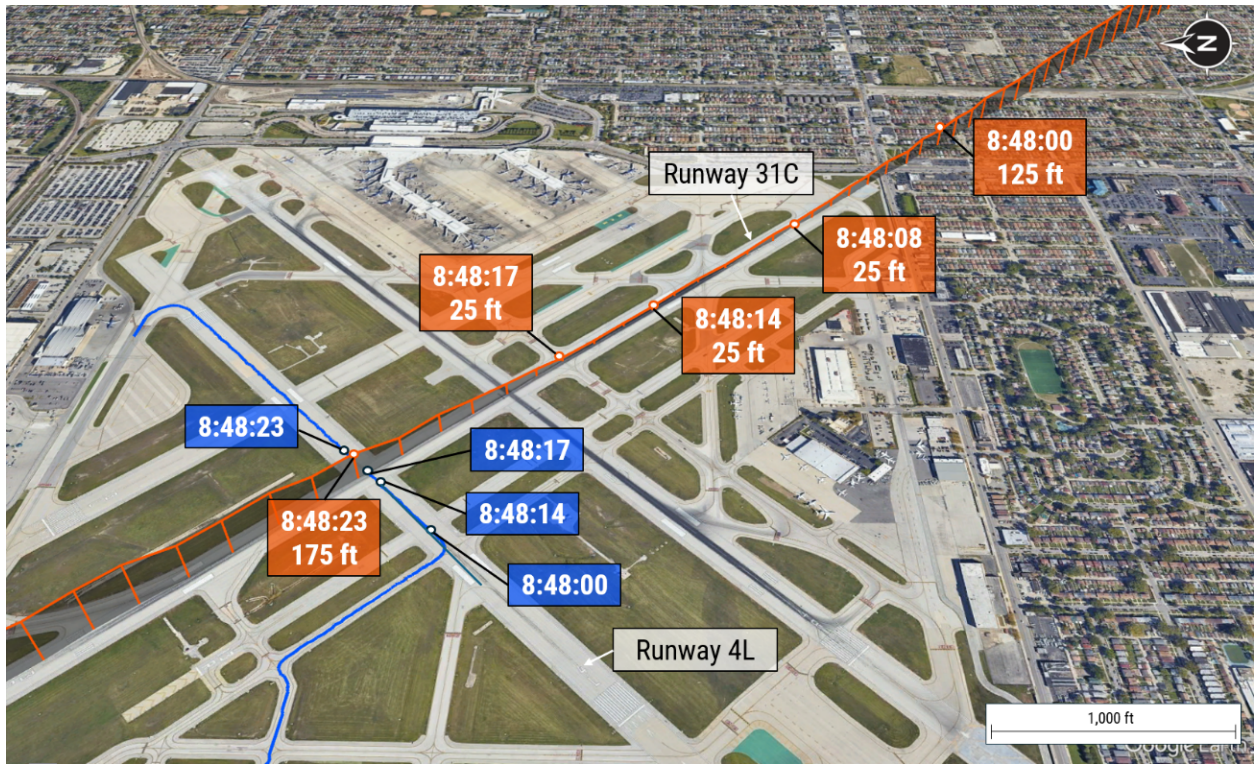
SWA2504 initiated the go-around while LXJ560 was crossing runway 31C. As LXJ560 cleared the active runway, SWA2504 passed less than 200 ft behind it (figures 1 and 2). SWA2504 subsequently made an uneventful landing a few minutes later. There was no damage to the involved airplanes and none of the 142 occupants aboard the SWA airplane and none of the 3 occupants on the Flexjet airplane were injured. LXJ560 was operating under the provisions of Title 14 *Code of Federal Regulations (CFR)* Part 91K as a flight from MDW to Tyson McGhee Airport (TYS), Alcoa, Tennessee. SWA2504 was operating under Title 14 *CFR* Part 121 as a regularly scheduled domestic passenger flight from Eppley Airfield (OMA), Omaha, Nebraska to MDW.

**Figure 1.** Flight paths for SWA2504 (orange) and ground path for LXJ560 (blue) with times and altitudes.

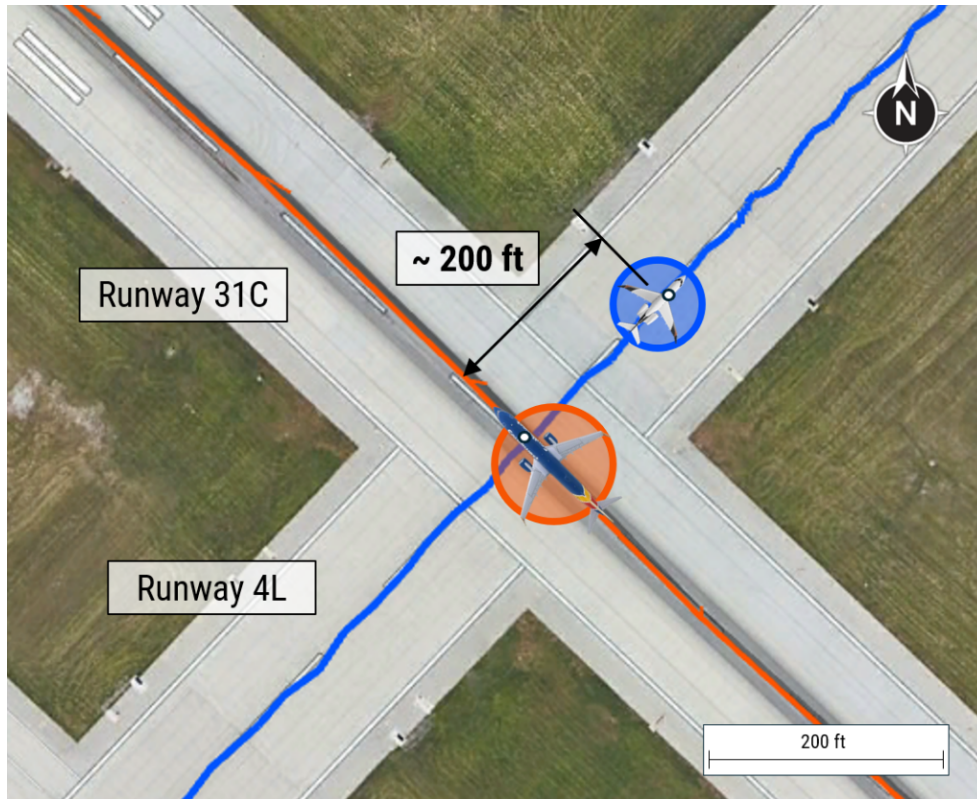
**Figure 2.** Flight paths for SWA2504 (orange) and ground path for LXJ560 (blue) showing minimum separation. The about 200 ft distance shown is the lateral distance between the approximate location of each airplanes' GPS antenna.

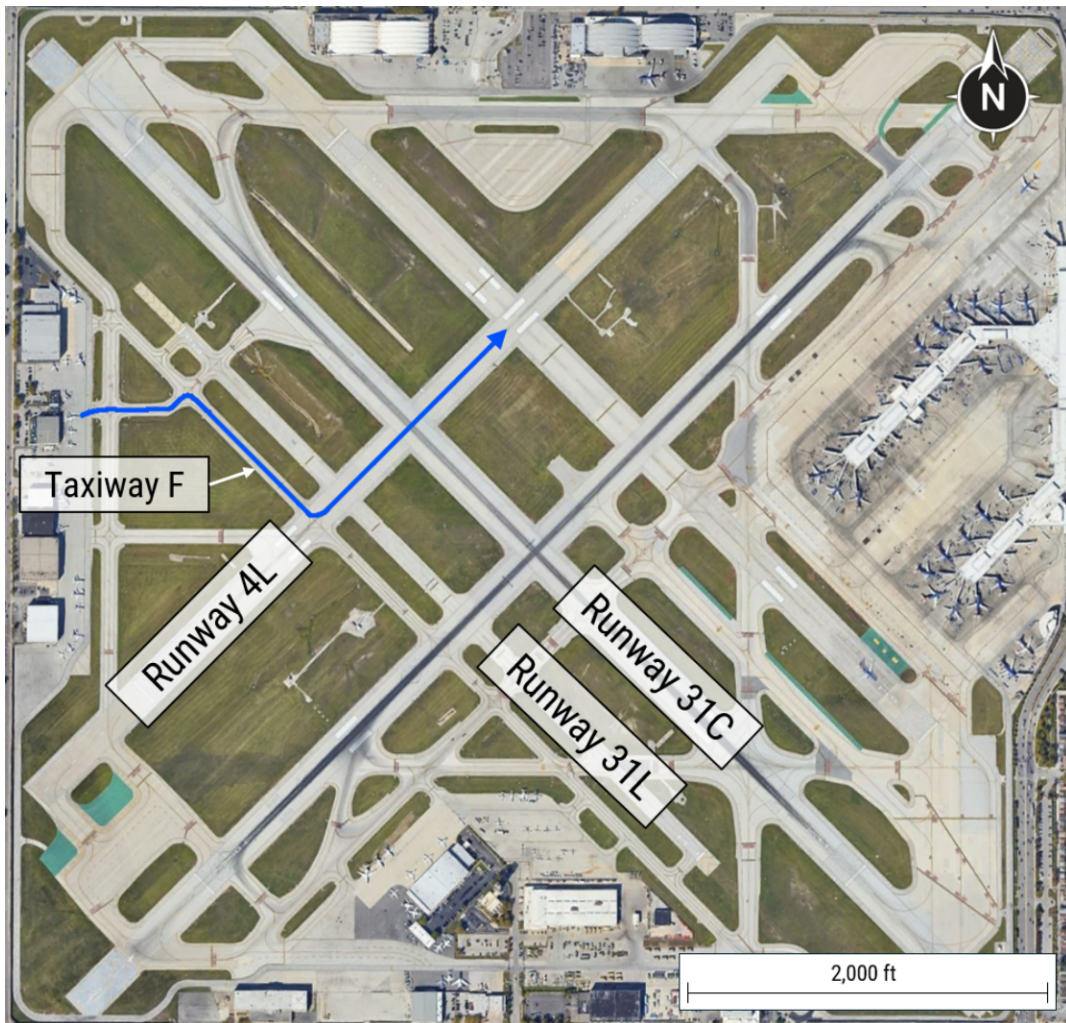
**Figure 3.** The blue line shows the taxi route for LXJ560.

According to postincident statements, the flight crew of LXJ560 indicated that as they turned left onto runway 4L/22R, the sun was impeding visibility from the right side of the aircraft, however they did not recall seeing any hold short line/pavement markings or any other signs for the 31L intersection as they taxied onto runway 04L/22R. They stated that taxiway F and runway 13R/31L were in close proximity to each other and by the time the nosewheel had straightened out, they were likely halfway across runway 13R/31L. They further stated that runway 13R/31L appeared to have a very similar width to taxiways and that they had not recognized it as a runway. The captain stated that as he approached runway 13C/31C he had thought it was runway 13R/31L. As they approached the runway intersection the crew stated they both looked to the left and to the right and did not observe the SWA airplane on final.
