October 2, 2025

MIR-25-36

# Hull Failure and Implosion of Submersible *Titan*

North Atlantic Ocean

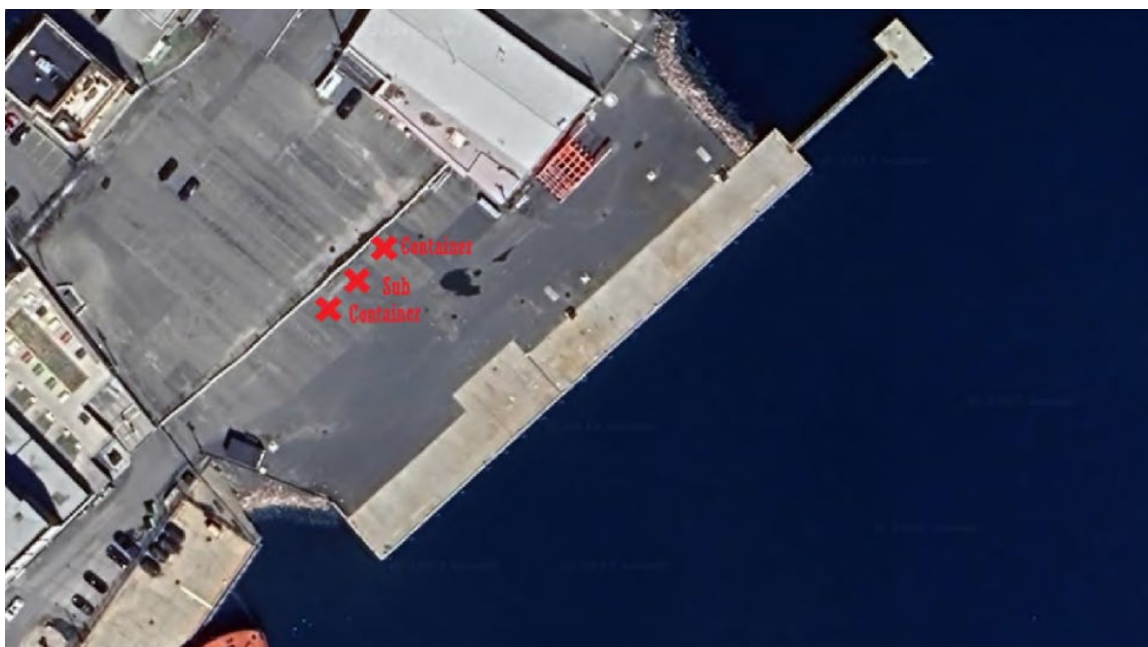
After the 2022 expedition, the *Titan* was initially stowed at an outdoor location in St. John's. It was left in a parking lot, outside, uncovered (see figure 9). In early 2023, the submersible was moved to storage at an indoor bay dedicated for ROVs at Memorial University's Marine Institute in St. John's. In April 2023, the vessel was moved to the Institute's Holyrood Facility for installation on the LARS for the 2023 expedition.

**Figure 9.** Overhead of parking lot in St. John's where the *Titan* was stored, uncovered, after the 2022 expedition. The locations of the *Titan* and two containers storing its equipment are marked with an X. (Source: A. Harvey)

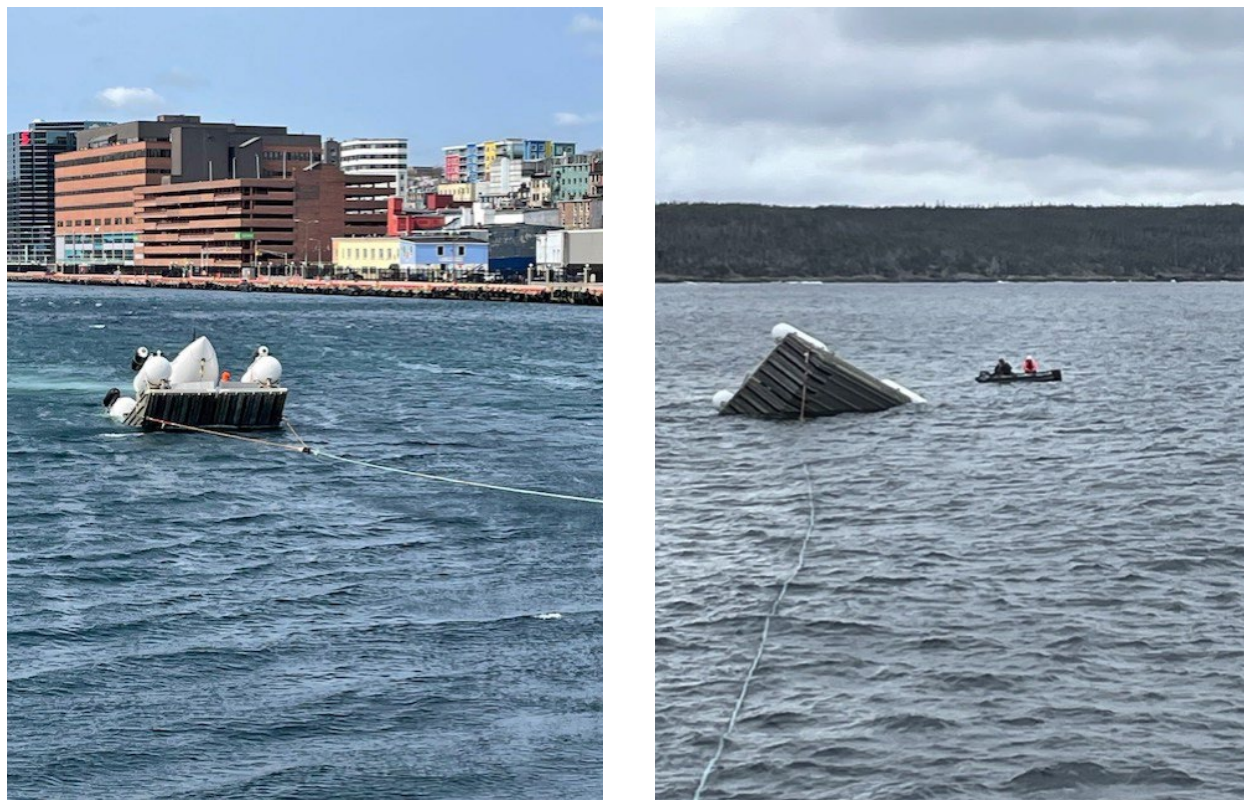
*Polar Prince* was towing the LARS with the *Titan* on board about 30 miles southwest of the *Titanic* site, the tow trimmed forward (instead of by the stern, as was typical), which OceanGate attributed to a “ghost fishing net.” According to OceanGate’s director of administration, the *Titan* lost a fairing in high seas, and the blanks on the bottom of the hull (where penetrations let water in to sink the vessel) came loose. The crew found the LARS listing, and divers had to make repairs.

**Figure 10.** Left to right: Operational mishaps during the 2023 expedition showing the aft starboard corner of the LARS tipped downward on May 20 while leaving St. John’s, and the aft end of the LARS tipped downward on May 27 in Witless Bay, Newfoundland and Labrador. (Source: Steven Taragel)

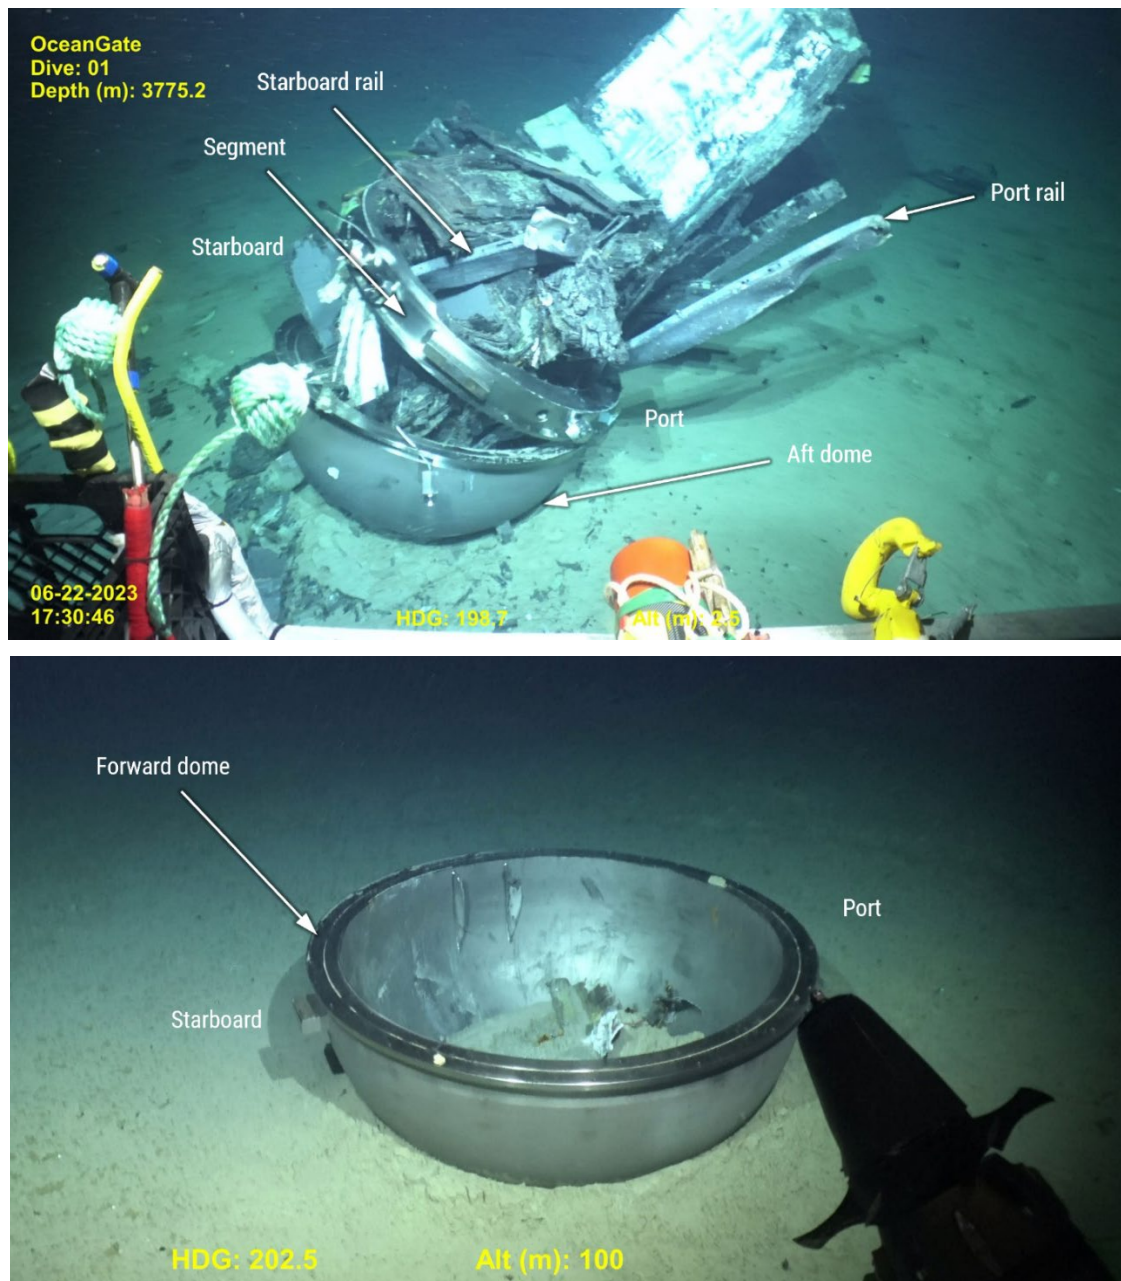
were located together in a comingled mass that included compressed metal, plastic, electronic components, and other materials; the forward dome was located by itself (see figure 11). The forward segment and tail section were also located by themselves. Other pressure vessel fragments, likely from the middle or forward portion of the cylinder, were scattered about the ocean floor. The aft segment was still attached to the aft dome by two flange bolts on the port side.

**Figure 11.** From top: *Titan* wreckage as discovered on the ocean floor, with aft dome, titanium ring (segment), and portion of cylinder separate from the forward dome. (Background source: Pelagic Research Services)

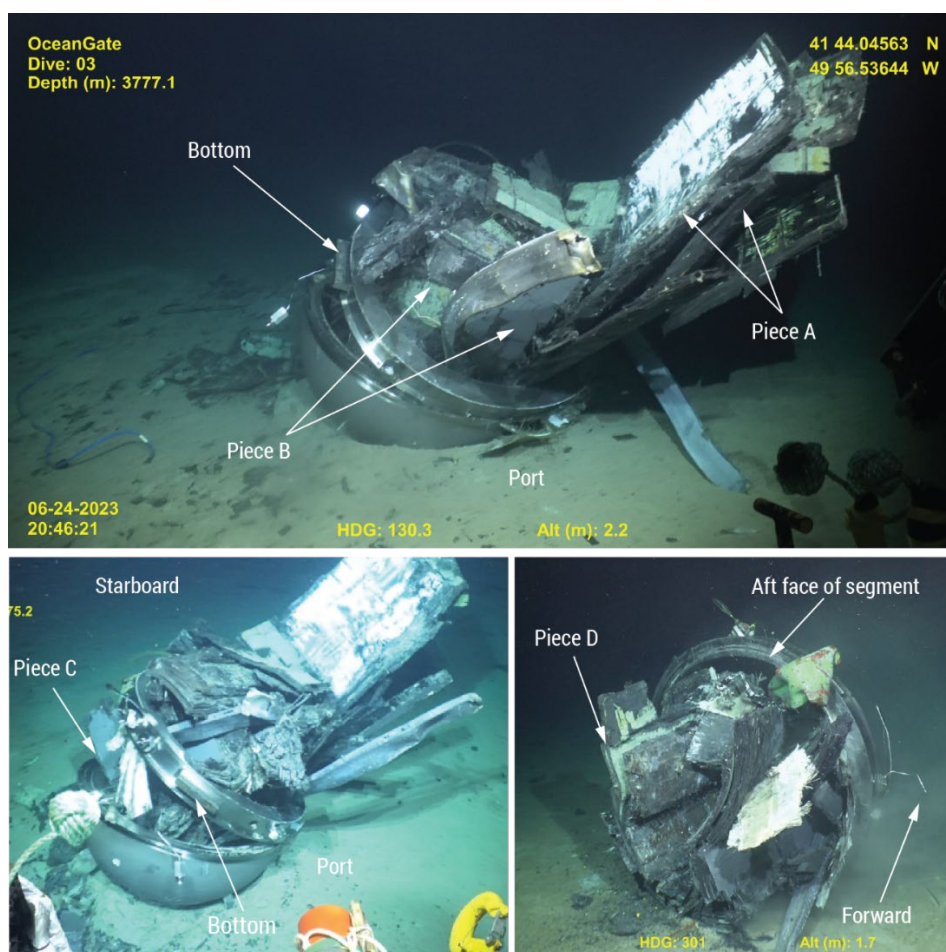
Examination of the wreckage from ROV video footage showed the pressure vessel had fragmented into multiple pieces. US Coast Guard and National Transportation Safety Board (NTSB) investigators identified several notable pressure vessel pieces and labeled them as Pieces A, B, C, and D (see figure 12). Investigators could see that the carbon fiber composite cylinder had delaminated into multiple layers nearly around the entire circumference and that the delaminations occurred between the co-bonded layers of the cylinder. One delamination was between layers 1 and 2 and the other was between layers 3 and 4. The delamination between layers 1 and 2 resided within the adhesive and showed signs of preexisting rubbing damage. The delamination between layers 3 and 4 appeared to have occurred within the adhesive on the port side and extended down toward the bottom side, while it resided within the carbon fiber composite elsewhere. On Piece D, which was found in the center of the wreckage but likely originated from the bottom of the pressure vessel, investigators identified a sigmoidal buckle (an inward bend combined with an adjacent outward bend). The *Titan* was a total loss.

**Figure 12.** Counterclockwise from top: *Titan* wreckage on ocean floor, showing pressure vessel pieces A, B, C, and D. (Background source: Pelagic Research Services)

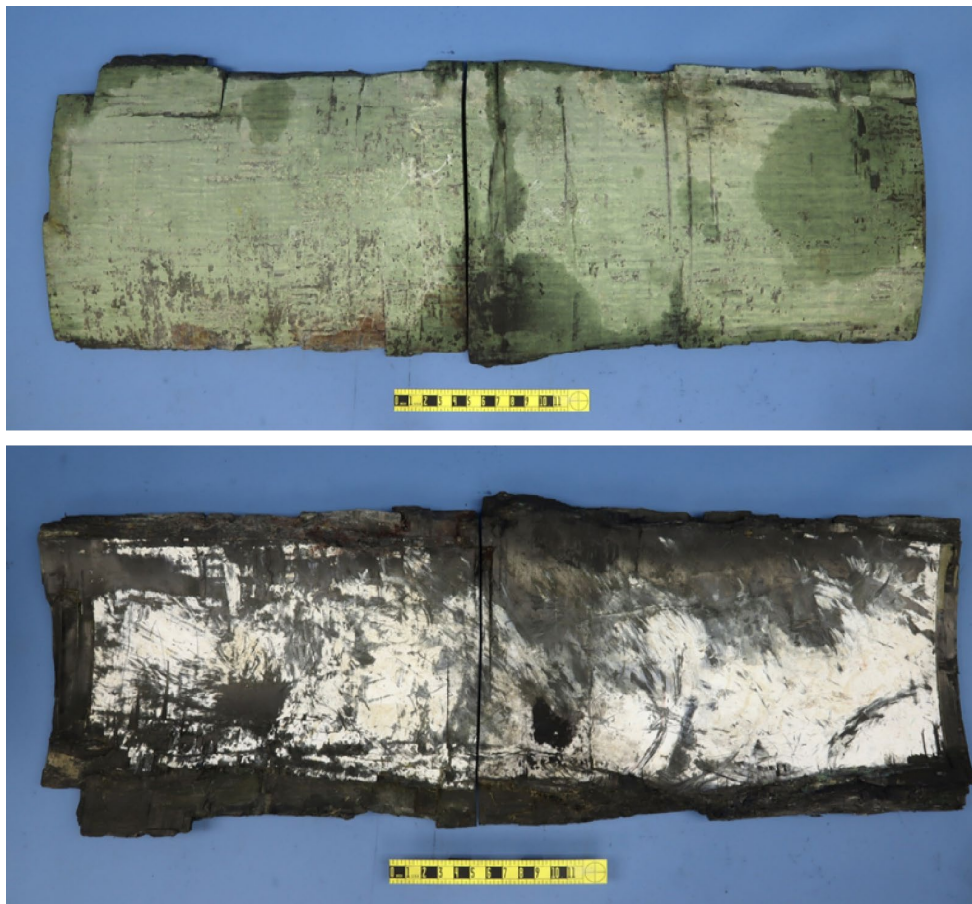
The NTSB Materials Laboratory examined a piece of the v2 composite cylinder, which had been recovered about 350 feet (107 meters) from the main wreckage and measured about 61 inches long by 20 inches wide by 1 inch thick. The outer surface of the recovered piece of the cylinder was coated by green film adhesive, and the inner surface was coated with white paint (the interior of the pressure vessel was painted white), indicating that the piece originated from layer 1, the innermost co-bonded layer (see figure 13). We examined the piece to characterize the structure and properties of the composite hull material and the adhesive bonding, as well as to determine, where possible, the modes of separation.

**Figure 13.** From top: Recovered carbon fiber composite pressure hull outer surface and inner surface.

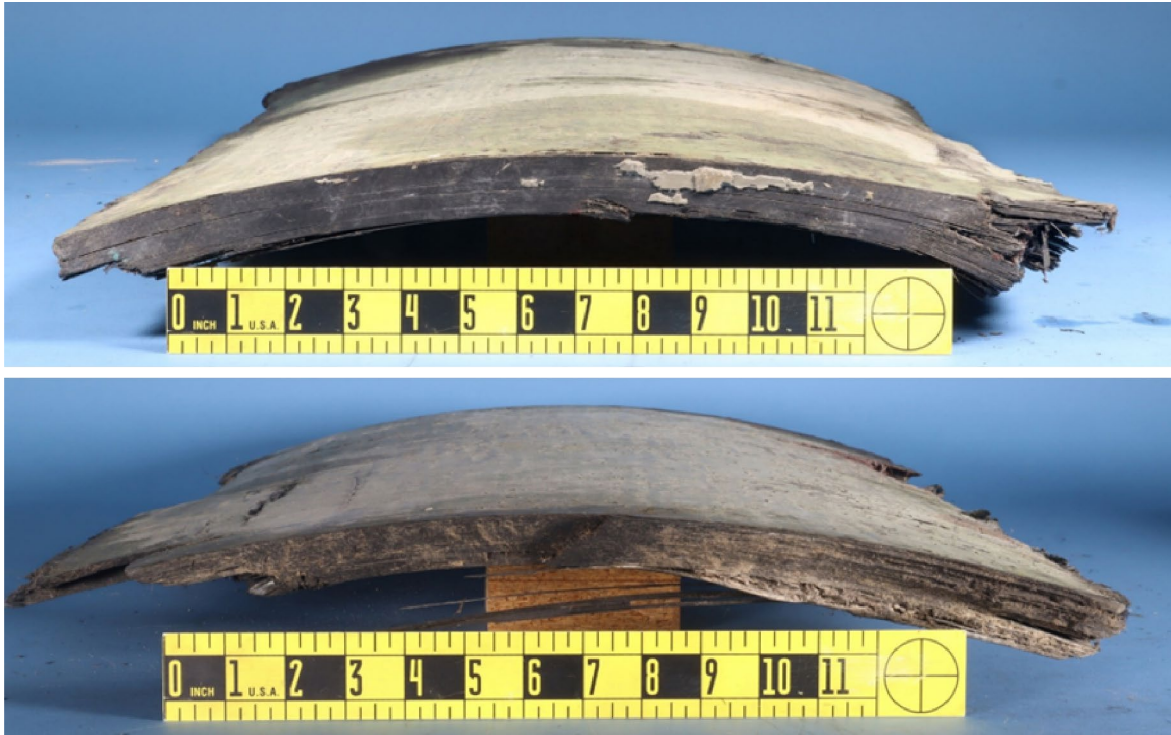
One end of the piece was machined, and some bits of cured adhesive were still attached. The other ends/edges were fractured (see figure 14).

**Figure 14.** From top: Recovered carbon fiber composite cylinder machined end face, and mid-span fractured face.

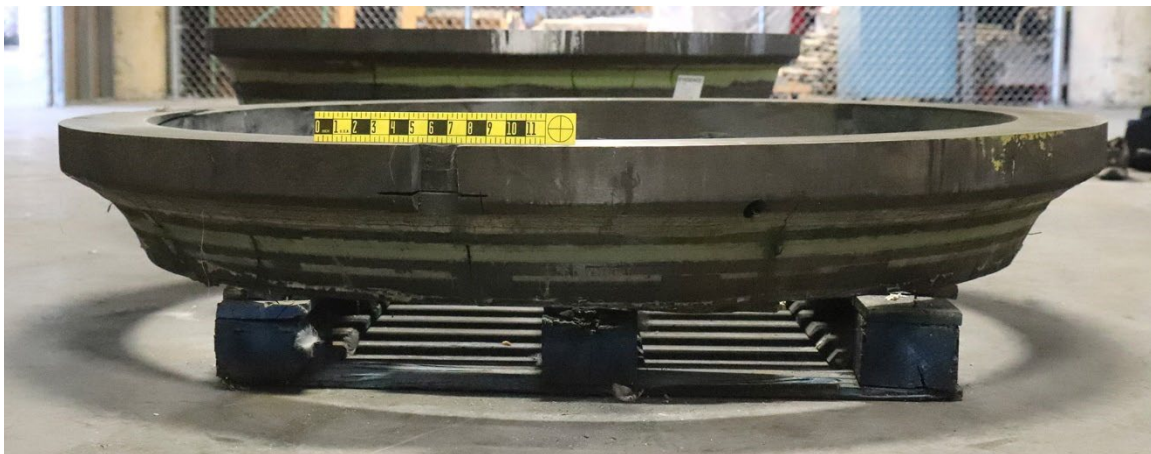
We also examined end pieces that had been trimmed from the v2 full-scale cylinder during the construction/production process (see figure 15).

**Figure 15.** Side view of a trimmed end piece of the *Titan* cylinder.

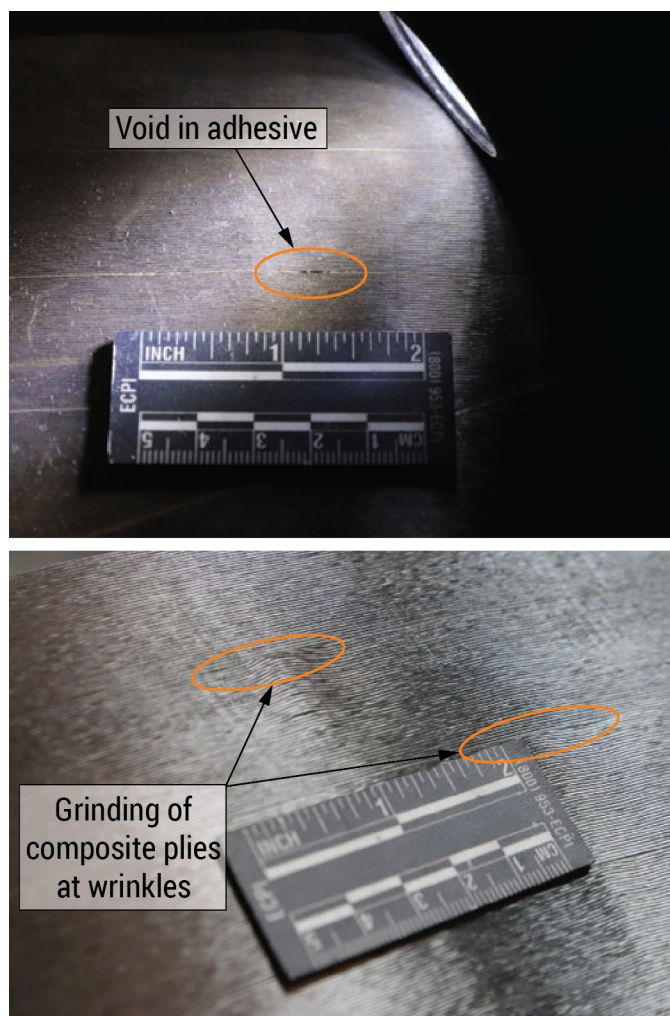
Our examination determined that there was porosity between plies, voids in the adhesive used to join the co-bonded layers, and a preexisting disbondment between the first and second co-bonded layers. Wrinkles and waviness in the carbon fiber were observed on the trimmed end pieces, and multiple wrinkles in the carbon fiber had been leveled flush with the outer surface using a grinding tool during the manufacturing process (see figure 16).

A volumetric void measurement determined that the average porosity content of the composite cylinder was about 2.7%. Microstructural analysis indicated that the porosity was localized in layers between the composite plies. The excess porosity resulted in an increase in layer thickness. Instead of 0.9975 inches thick (the expected thickness), the layers were between 1.019 inches and 1.033 inches thick. Combined with the thickness of the adhesive layers, the two trimmed cylinder ends were 5.166 inches and 5.175 inches thick. The excess thickness necessitated trimming the outer diameter of the cylinder in order for it to fit inside the annular C-channels on the titanium rings, which could only accommodate a 5-inch-thick cylinder. V-notch shear tests in the through-thickness direction showed significant variability, ranging from 6.92 to 12.05 kilopounds per square inch.<sup>29</sup>

**Figure 16.** From top: Void in the adhesive layer tenting around a wrinkle, and grinding of outer carbon fiber plies at a wrinkle.

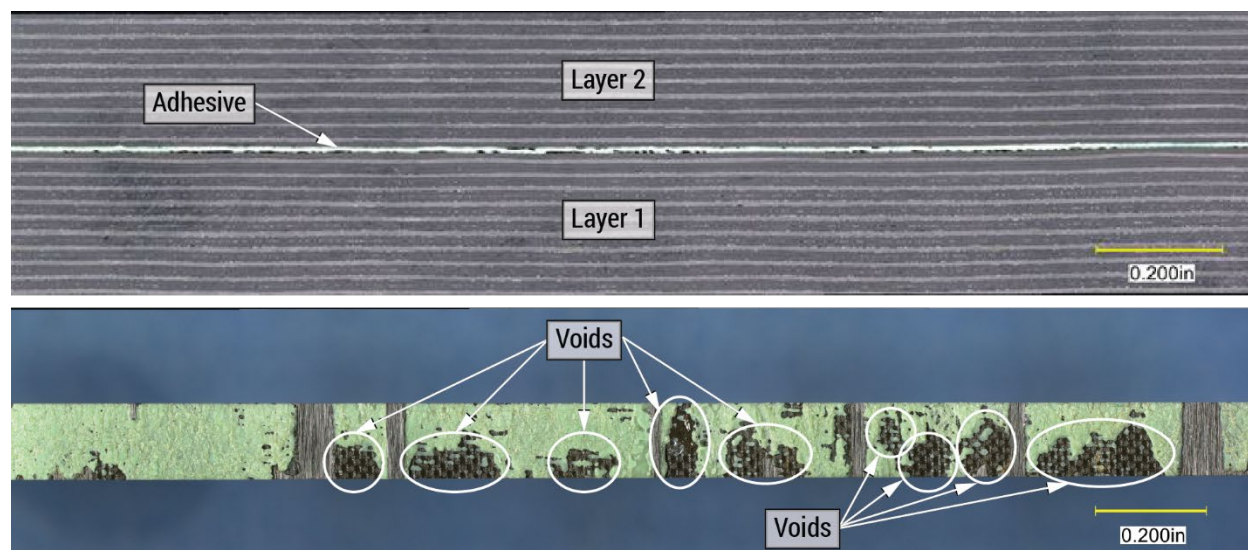
Cross sections through the adhesive used to join co-cured layers showed voids at the layer interfaces (see figure 17). The voids were present in all layers but were significantly greater in size and number at the interface between the first and second layers and the third and fourth layers. For example, two voids, one from the layer 1/2

interface and one from the layer 3/4 interface, measured 0.6 inches and 0.4 inches in length, respectively. The voids resulted in a gap between the adhesive and the underlying layer.

**Figure 17.** From top: Cross section of layers 1 and 2, showing adhesive between layers, and voids in the adhesive between layers 1 and 2.

The examination determined that the adhesive on the top of the recovered layer 1 piece had likely failed before the casualty, resulting in an internal delamination between the first and second layers. The surface was characterized by adhesive regions, voids, and carbon fiber regions. The adhesive regions were rubbed flat and adhesive wear debris was found collecting in the voids. The rub marks in the adhesive were oriented in the lengthwise direction. Cracks in the adhesive and carbon fiber were consistent with shear sliding between the already-separated first and second layers during the implosion.

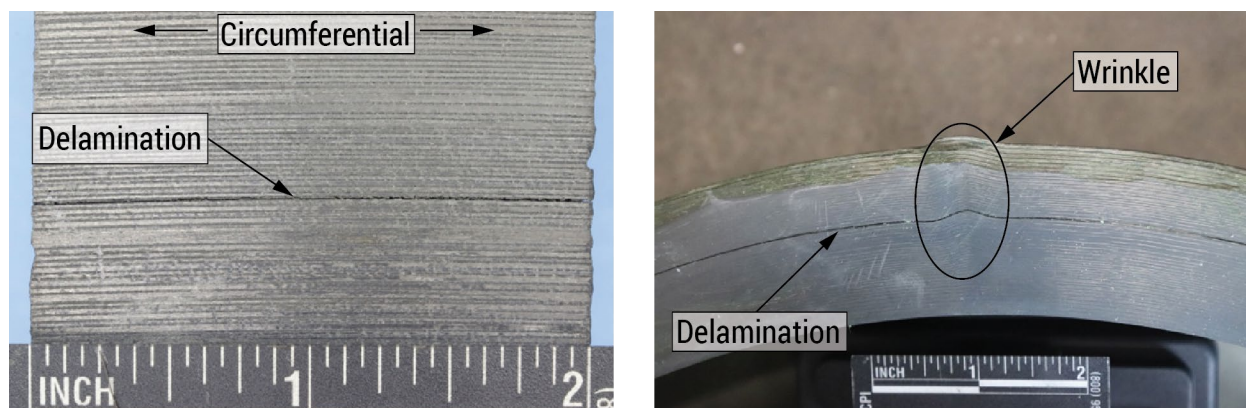
The NTSB also examined trimmed end pieces from the v1 full-scale pressure vessel (which had been condemned) and the two one-third scale models manufactured after the v1 full-scale pressure vessel and before the v2 pressure vessel. The v1 pressure vessel cylinder's trimmed end contained multiple delaminations and voids. Both scale models' trimmed end pieces had notable wrinkles and delaminations (see figure 18).

**Figure 18.** From left to right: Centerline delamination in trimmed end piece of first full-scale *Titan* pressure vessel, and wrinkle and delamination in trimmed end piece of one-third scale model.

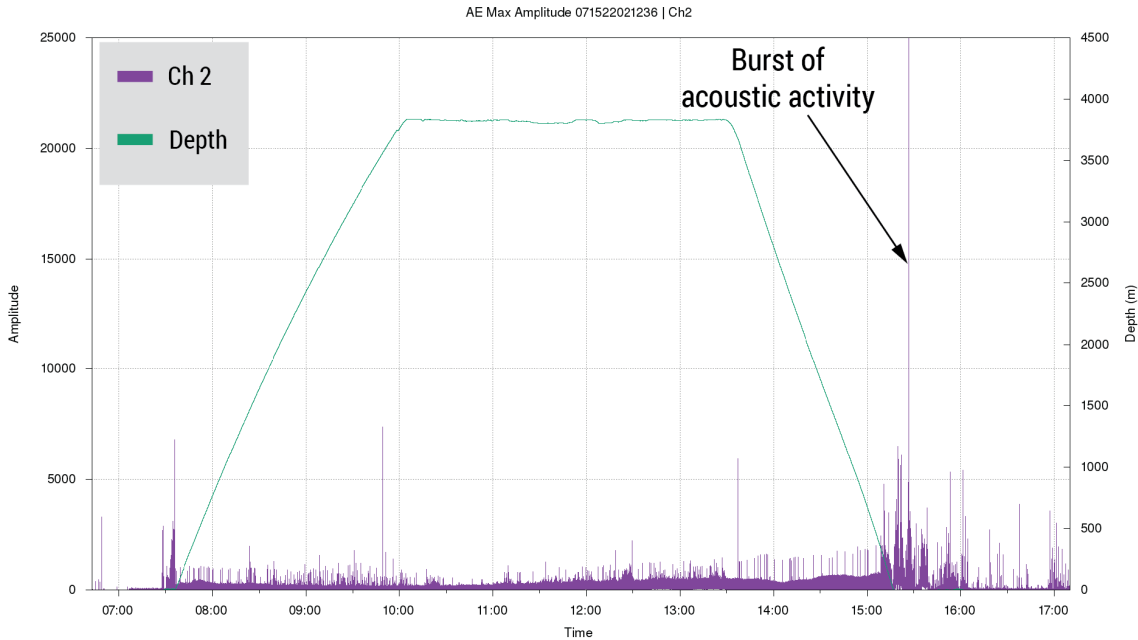
specialists heard a “loud bang,” showed a burst of acoustic activity and a sudden jump in some of the strain gages between about 1515 and 1530 (see figure 19 and figure 20).

**Figure 19.** Time plot from dive 80 (time of day is Newfoundland and Labrador daylight time), showing acoustic activity (purple) and depth (green). (Background source: OceanGate)

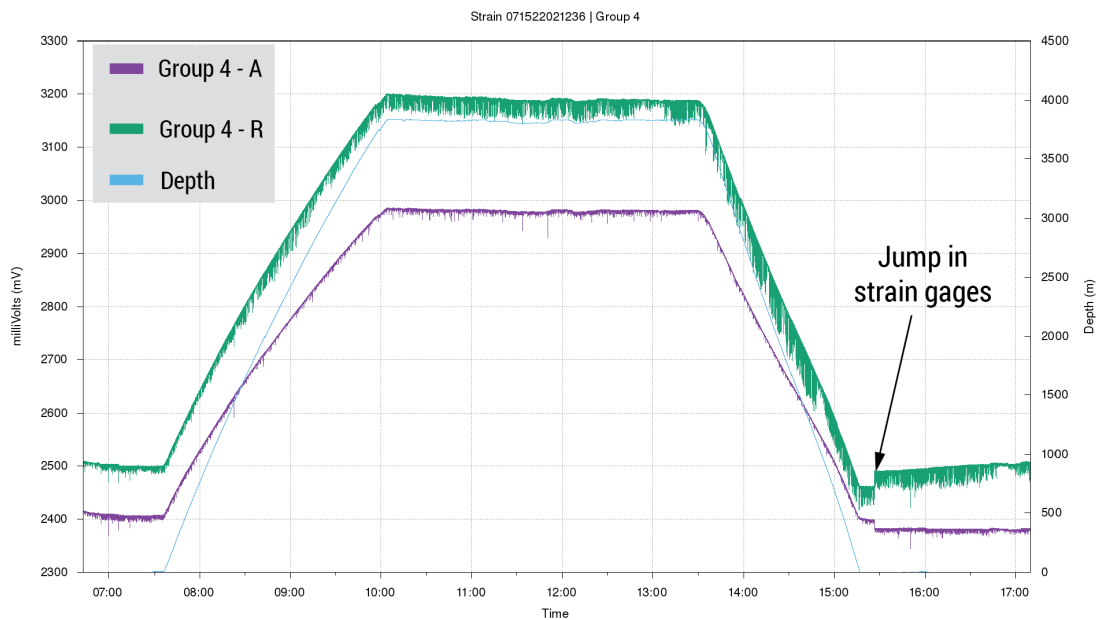
**Figure 20.** Strain gage output from dive 80, showing hoop strain (green) and longitudinal strain (purple) (time of day is Newfoundland and Labrador daylight time). (Background source: OceanGate)

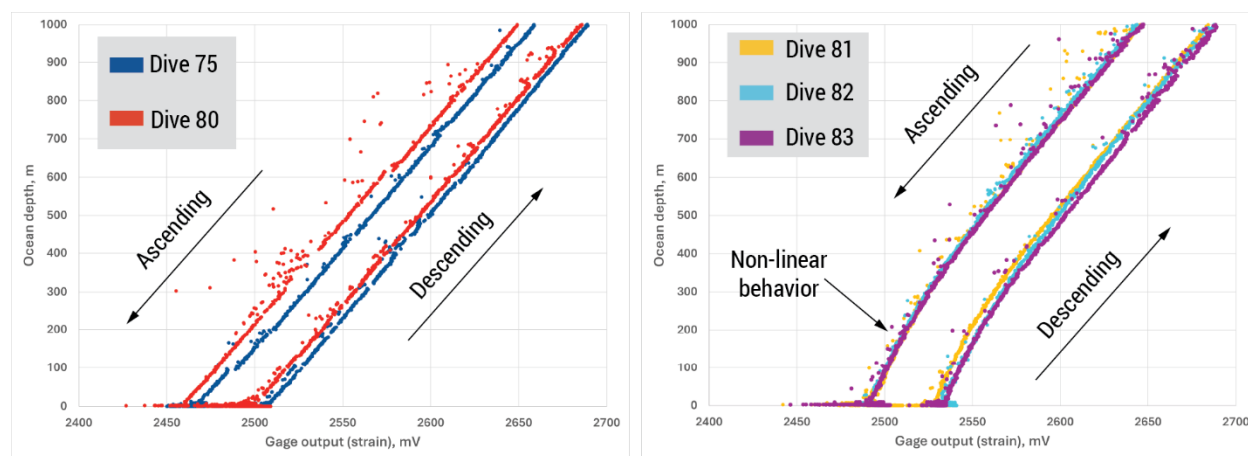
Following a standard approach for evaluating the mechanical response of materials, the NTSB analyzed the OceanGate dive data by plotting strain data against dive depth.<sup>37</sup> Through dive 80, the strain response of the hull was linear at all depths (a typical mechanical behavior). Changes were observed in the initial strain response of the hull following dive 80. During dive 81, the first dive after the audible event, the strain response at low depth was non-linear. The same non-linear response was observed for dives 82 and 83 (see figure 21). Changes in strain response were observed for other strain gages as well.

**Figure 21.** Strain gage output for the first and last 1,000 meters of dive depth for dives 75 and 80–83 (gage group 4 – hoop strain gage). The curves have been aligned using the linear portion of the descent phase of the trip. The strain for dives 81, 82, and 83 show non-linear behavior below 500 meters (1,640 feet) depth.
