# Aviation Investigation Preliminary Report

| <b>Location:</b> | Flagstaff, AZ | <b>Accident Number:</b> | WPR26FA098 |
| <b>Date &amp; Time:</b> | February 4, 2026, 22:16 Local | <b>Registration:</b> | N56AZ |
| <b>Aircraft:</b> | Bell 407 | <b>Injuries:</b> | 2 Fatal |

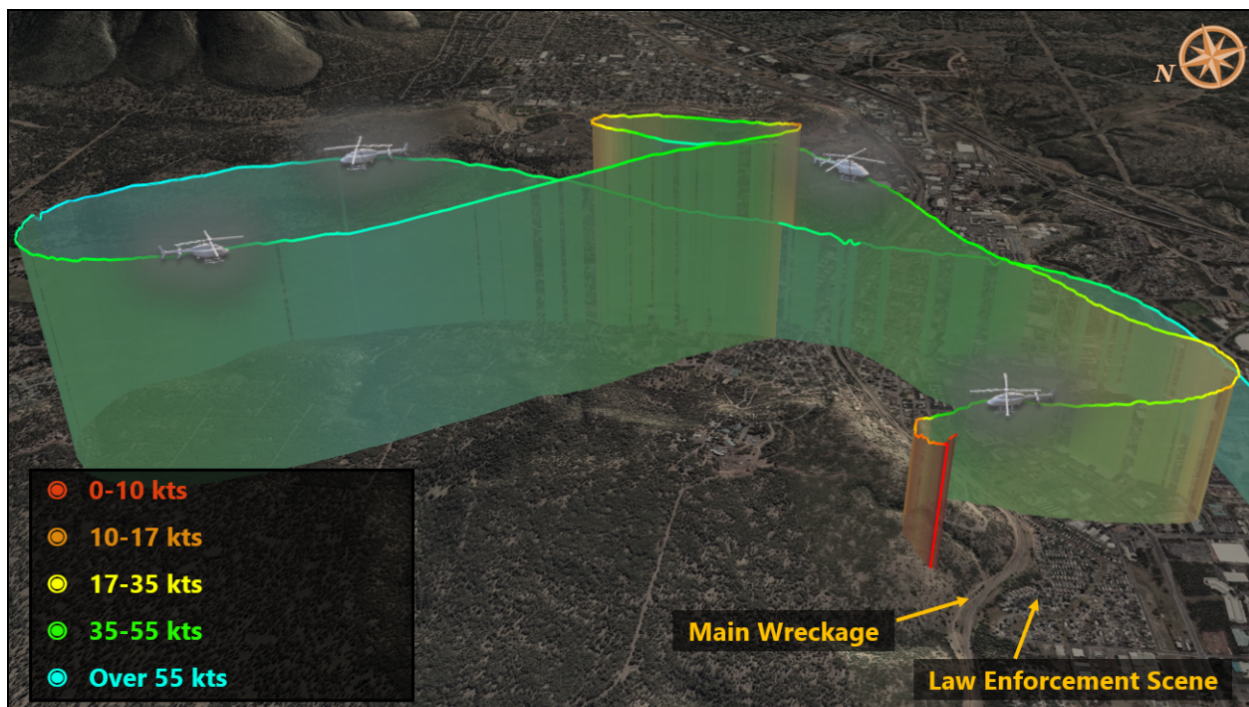
Figure 2: Flight path displaying airspeeds

The pilot maneuvered the helicopter in a gradual climb north of the neighborhood and performed a left 180° turn to return south to allow clearance for a helicopter that was inbound to Flagstaff Medical Center. At 2212:10, while the helicopter was at an altitude of 9,950 ft msl, it passed in the vicinity of the hospital-bound helicopter, which was on a northeast route at about 7,200 ft msl. Thereafter, the helicopter performed a left 360° turn and returned south toward the law-enforcement scene while descending to 8,900 ft msl (see figure 2 below). The helicopter then turned north and performed a gradual climbing left turn, consistent with aligning for an out-of-ground-effect (OGE) hover to maintain visual contact of the suspect. At 2216:24, the TFO initiated a radio transmission to law enforcement personnel on the ground; there were no indications of any abnormalities during the communication.

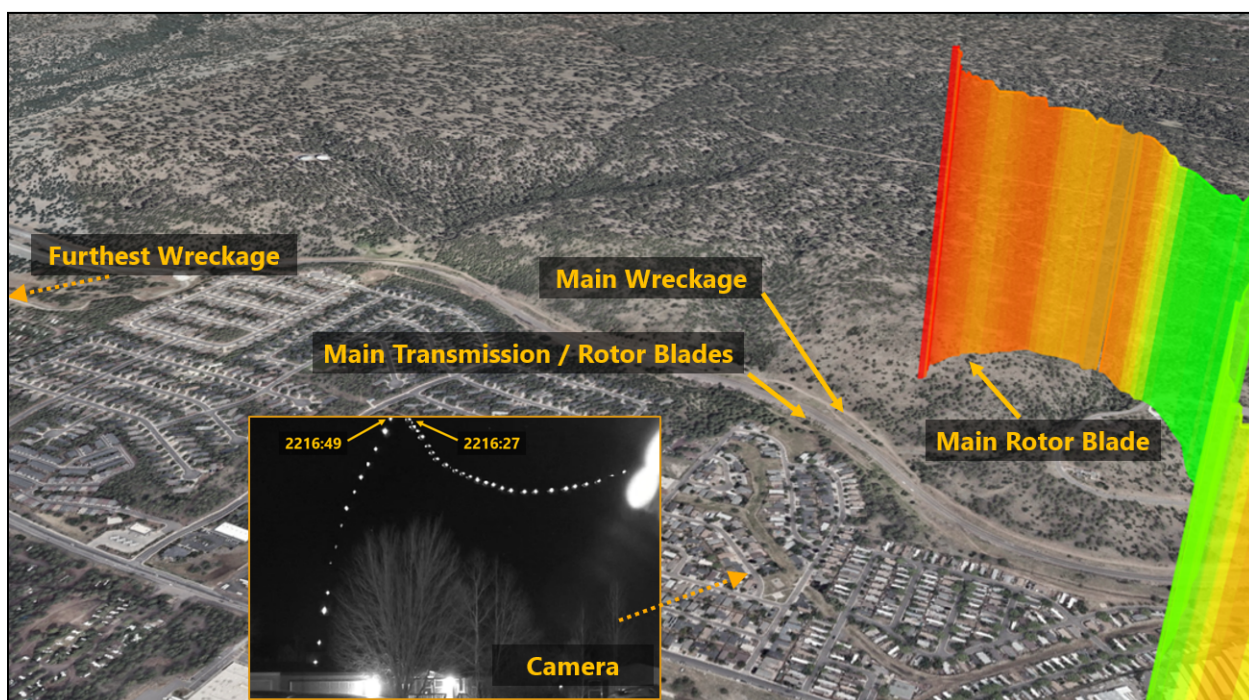
Figure 3: Picture of wreckage distribution and composite of video

The main wreckage was located on a flat dirt access road about 3 nm north of the Flagstaff Airport at an elevation of 7,010 ft msl. A section of the Burlington Northern Santa Fe (BNSF) railway tracks was located about 100 ft south of the main wreckage. The wreckage was distributed along a debris path on a median bearing of 250°; the most distant wreckage was located more than 6,150 ft from the main wreckage.

The main rotor hub, main rotor transmission, and three main rotor blades were located about 165 ft south of the main wreckage (see figure 3 below). The fourth main rotor blade, blade grip, and portion of its respective yoke were not located with the main rotor assembly; it was separated from the rotor hub and located 650 ft northeast of the main wreckage. All blades were lightly coated with an orange/yellow oil film.
