# Aviation Investigation Preliminary Report

| <b>Location:</b> | New York, NY | <b>Accident Number:</b> | DCA26MA161 |
| <b>Date &amp; Time:</b> | March 22, 2026, 23:37 Local | <b>Registration:</b> | C-GNJZ |
| <b>Aircraft:</b> | Mitsubishi CL-600 | <b>Injuries:</b> | 2 Fatal, 6 Serious, 33 Minor |

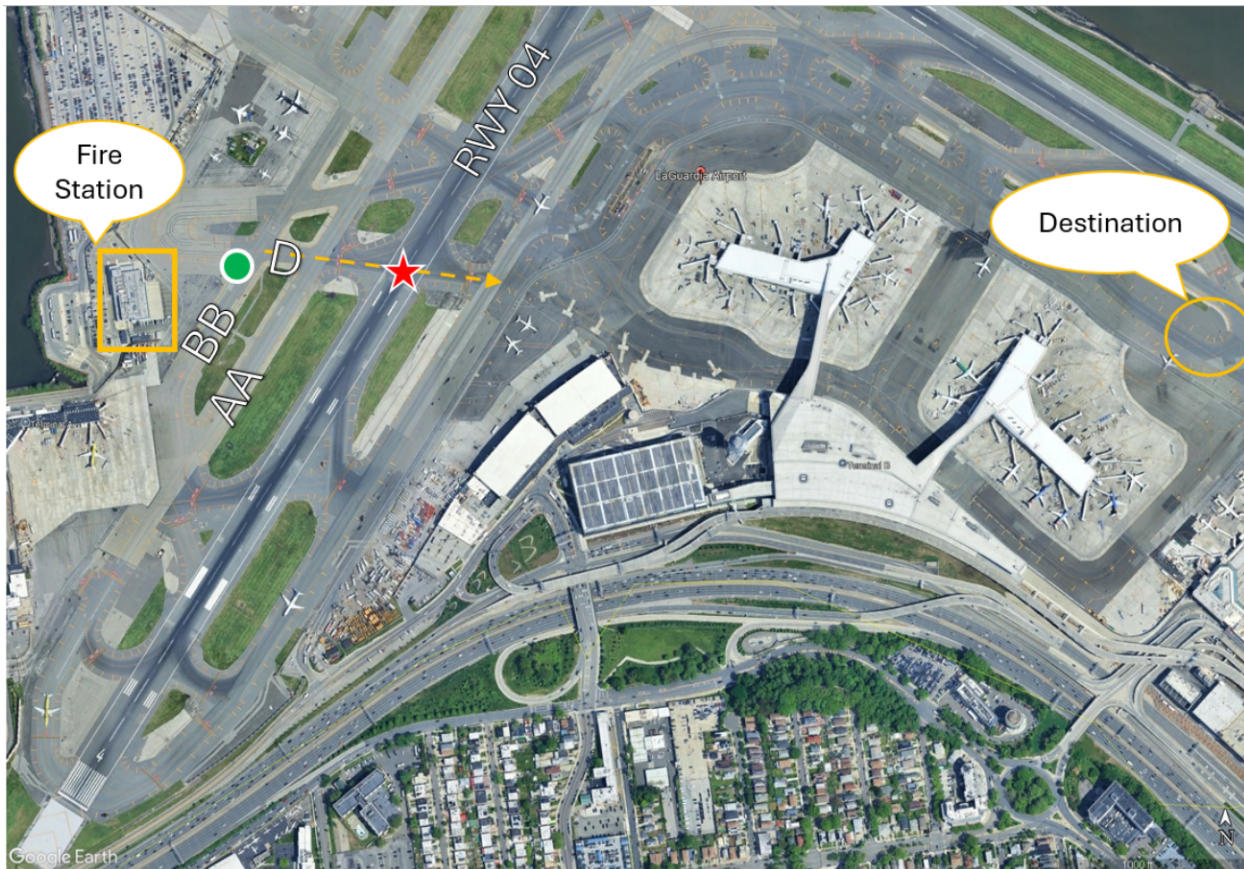
At 2335:28, the accident ARFF vehicle (R35) left the fire station area along with the other six vehicles. Jazz flight 646 was about 4.6 nautical miles from taxiway D at an altitude of about 1,500 ft. The vehicles initially gathered near the intersection of taxiways BB and D, shown as a green circle in figure 1. The intended path was to continue on taxiway D, cross runway 4 (depicted with dashed arrow), and then proceed to the destination noted on the right side of figure 1.

**Figure 1.** Google Earth image of the accident area, with the green circle indicating where the ground vehicles initially gathered, the yellow dash line their intended path on taxiway D, and the red star indicates where the collision occurred.

Truck 1 turned toward the left just prior to the collision. The airplane's rudder deflected about 6° to the left just prior to the end of the flight recorder data. The collision occurred at the intersection of taxiway D and runway 4 denoted by the red star in figure 1. The airplane's last recorded ground speed before the collision was 90 knots (104 mph).

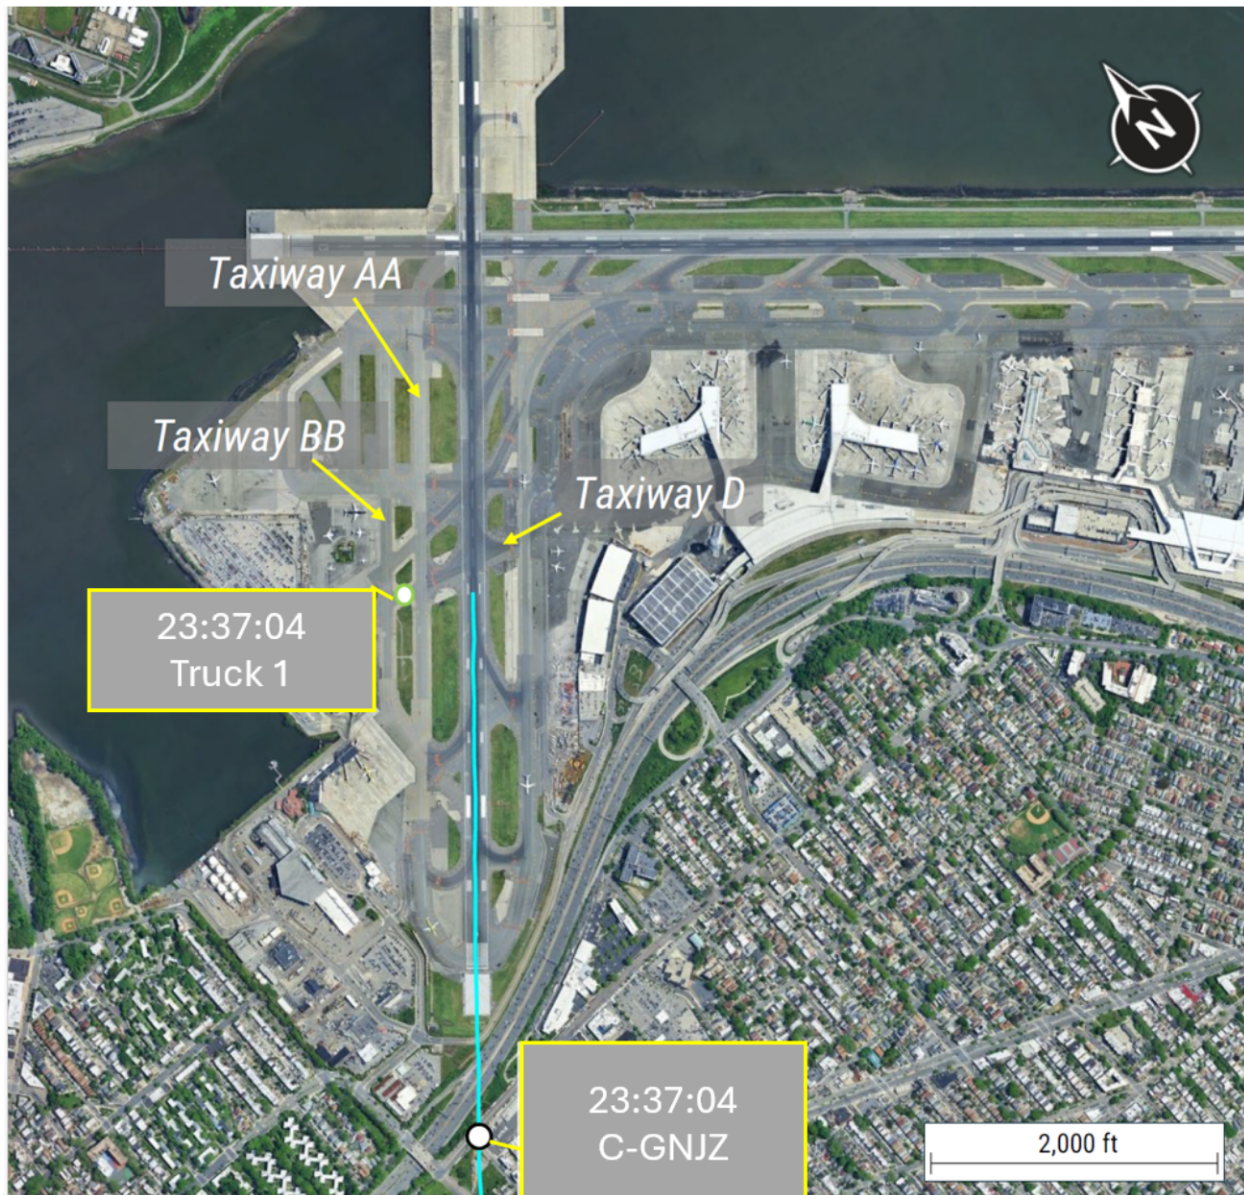
At 2336:56, Truck 1's crew replied to ATC with "Truck 1 and company", and the LC acknowledged. Truck 1 then requested "Truck 1 and company" to cross runway 4 at taxiway D, and the LC instructed them to cross. At that time, 2337:04, the airplane was at an altitude of about 130 ft above ground and about ¼ mile on final approach, which was about 4,400 ft away from taxiway D (see figure 2).

**Figure 2.** R35 (Truck 1) and Jazz flight 646 (C-GNJZ) positions at 23:37:04.

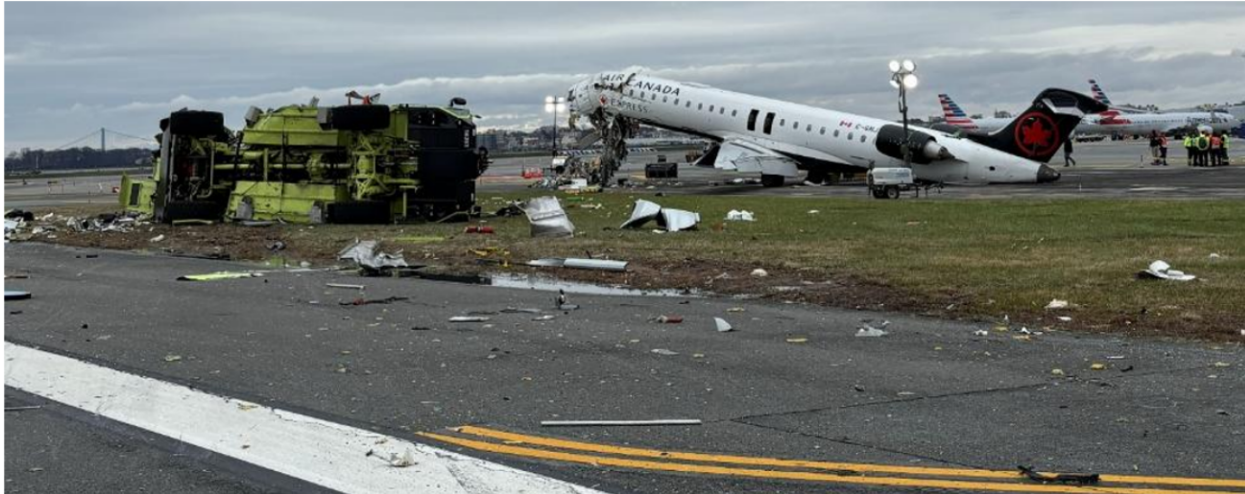
The airplane came to rest adjacent to taxiway B between taxiways D and E, upright on a heading of about 28° magnetic. Initially it was in a nose down attitude, due to the crush damage and partial separation of the forward fuselage and nose landing gear. Truck 1 came to rest just northwest of the airplane, on its left side, on a heading of about 206° magnetic.

**Figure 3.** View of both vehicles after collision.

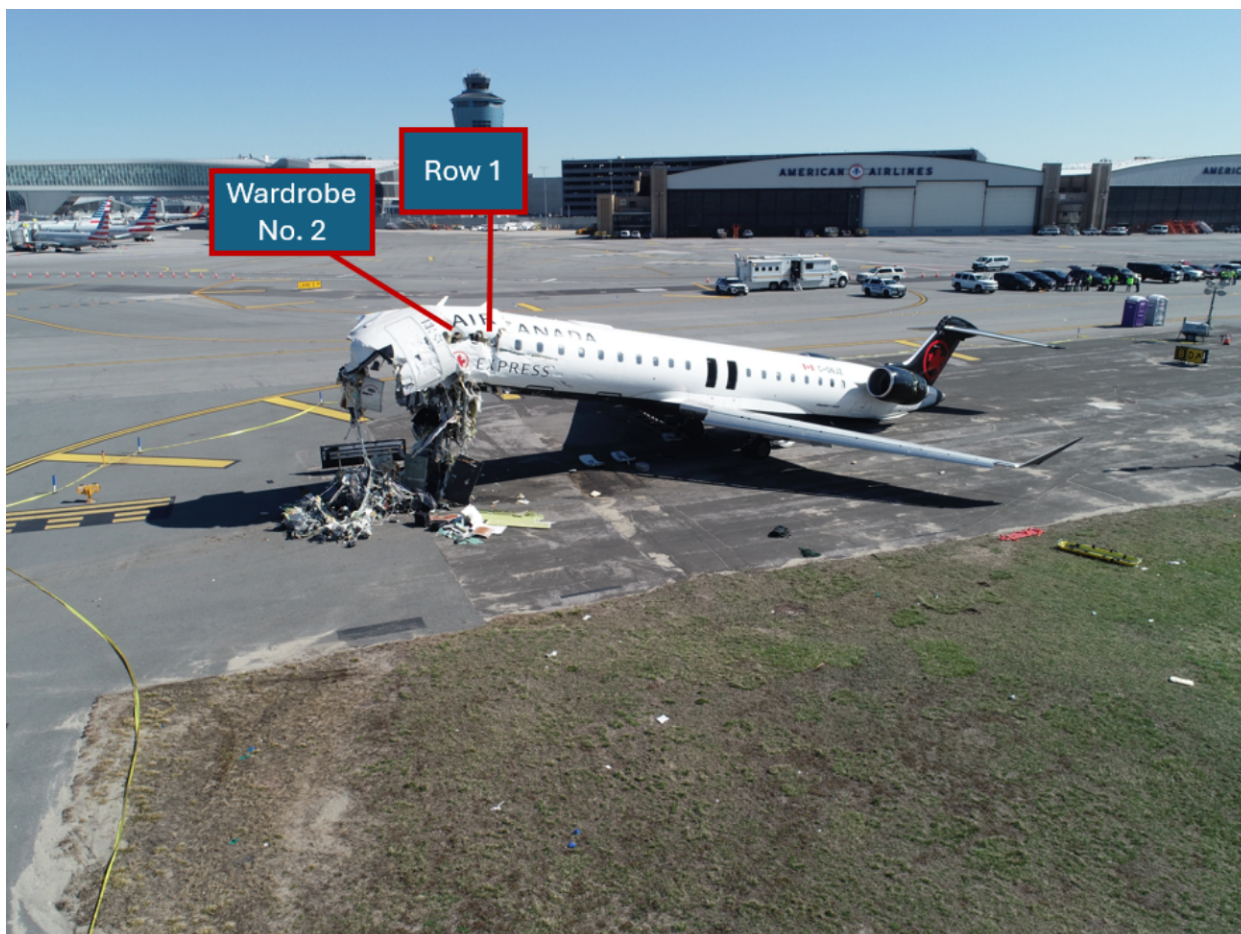
An examination of the airplane revealed that the most severe damage was forward of passenger seat row No. 1. Crush damage extended from the nose, to about the wardrobe No. 2 (coat closet) on the left side of the cabin and to about the forward lavatory on the right side. The two pilot seats, an unoccupied flight deck observer seat, and the forward flight attendant seat were separated from the airplane and found in the debris to the northeast (near the aft end) of Truck 1. All passenger seats were intact and remained secured to their attachment points. Seats 1A and 2A had inboard sidewall and seat leg deformation. The remainder of the passenger seats sustained minor or no damage.

There were no anomalies found with the pitch, roll, or yaw flight control surfaces. The leading edge slats and trailing edge flaps were found in their fully extended positions. All eight spoilers were found in the retracted position, however a review of the flight recorder data indicated that the ground spoilers activated about six seconds before the end of recorded data. Both thrust reversers were found in their fully deployed positions.

**Figure 4.** A view of the accident airplane from the left side.

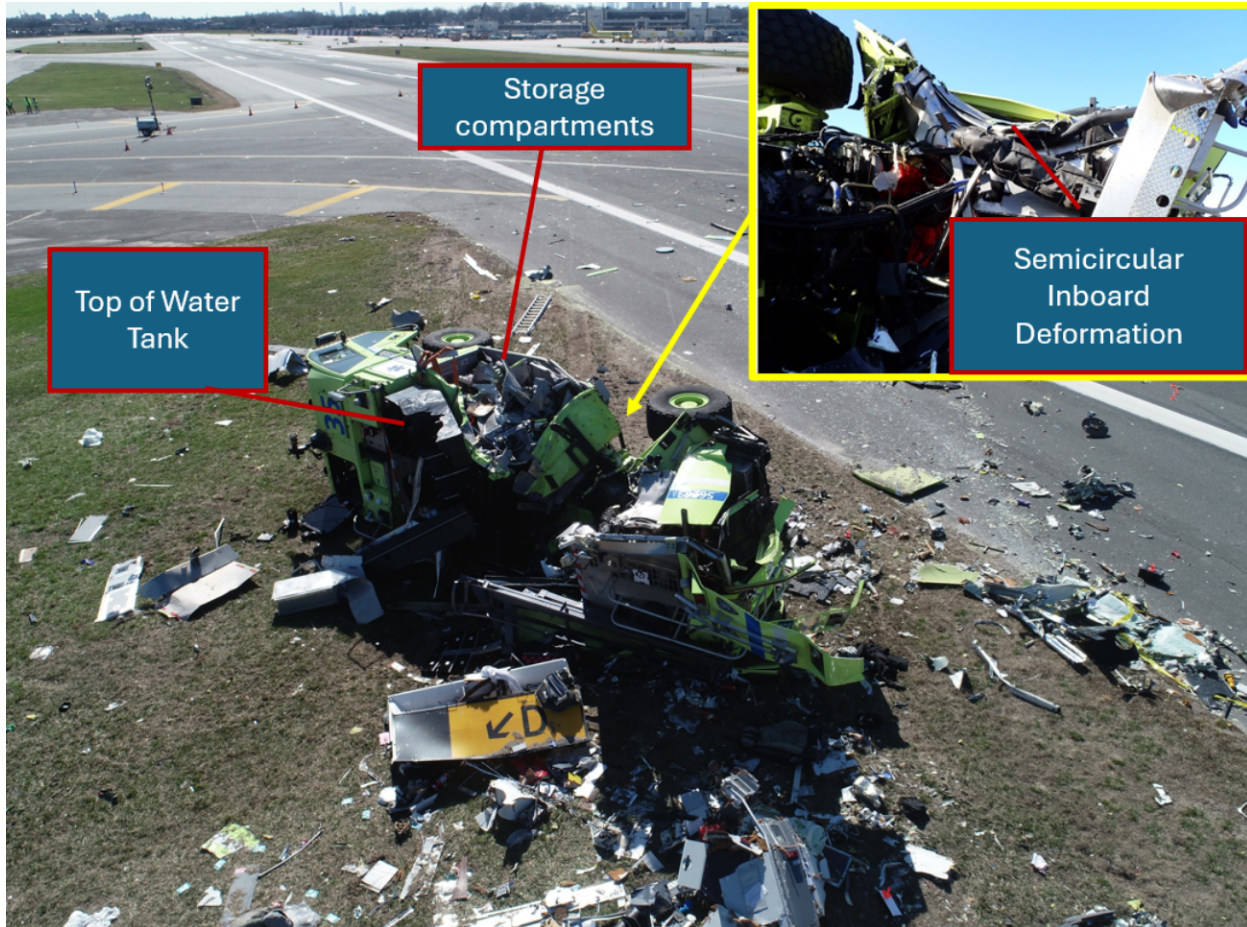
Examination of the R35 ARFF truck revealed it sustained substantial damage to its right-side body structure and equipment storage compartments. The 1,500-gallon water tank was fragmented, and all of the water was released. The 210-gallon foam tank was largely intact, though breached, and all of the foam was released. The right-side body structure had a semicircular indentation in the inboard direction, just forward of the right rear wheel. The operator cab was largely undamaged.

**Figure 5.** Truck 1 with a view of the right and top side of the truck.

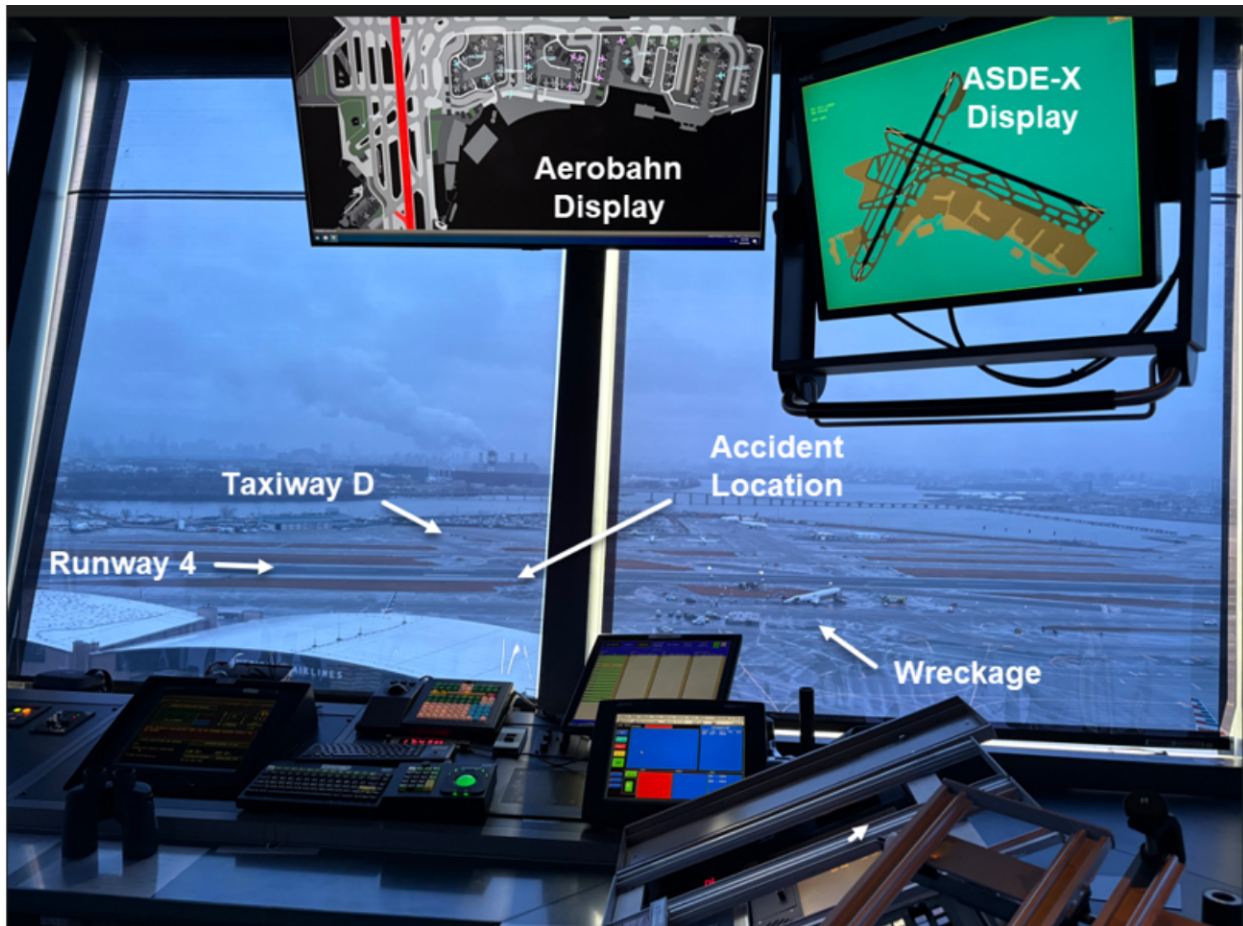
**Figure 6.** Photo taken from the ground control position looking toward runway 4 at taxiway D.

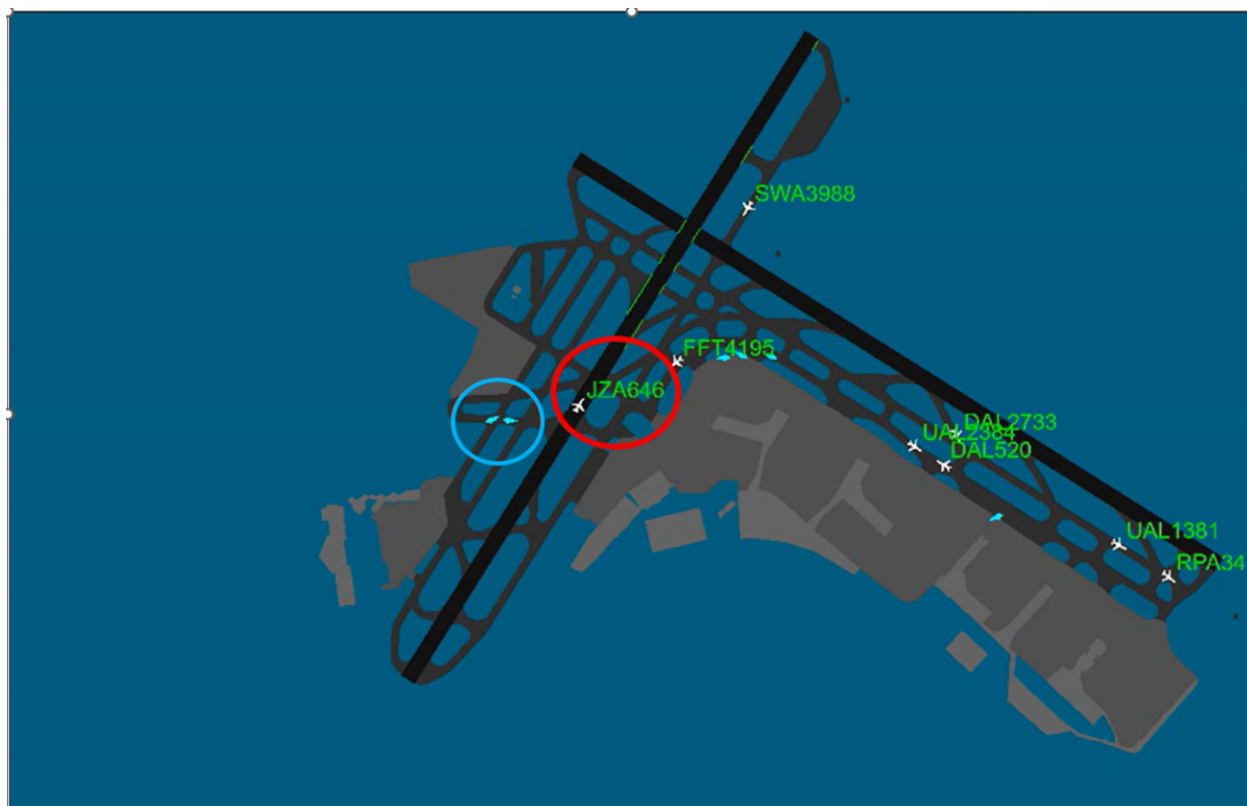
A review of the ASDE-X system data by the FAA determined that the system did not generate an aural or visual alert on the ASDE-X displays in the LGA ATC tower to warn controllers of the potential runway conflict.

Multiple ground vehicles, none of which were equipped with transponders, were intermittently detected as radar targets, while holding on taxiway D at taxiway BB. However, due to their close (and varying) proximity to each other, and the intermittent merging and unmerging of radar targets, the ASDE-X system was unable to establish high-confidence tracks. At the time of the accident, ASDE-X displayed only two radar targets on taxiway D (near taxiway BB), rather than all seven of the response vehicles as distinct targets at their respective locations, see figure 7.

Without transponder-equipped vehicles, the ASDE-X system could not uniquely identify each of the seven responding vehicles or reliably determine their positions, or tracks. As a result, the system was unable to correlate the track of the airplane with the track of Truck 1 (or any of the other vehicles in the group) and did not predict a potential conflict with the landing airplane.

**Figure 7.** ADSE-X display just after the accident airplane passed taxiway D. JZA646 is the accident airplane and is shown within the red circle. The ground vehicles targets are shown in the cyan circle. (Source: FAA)

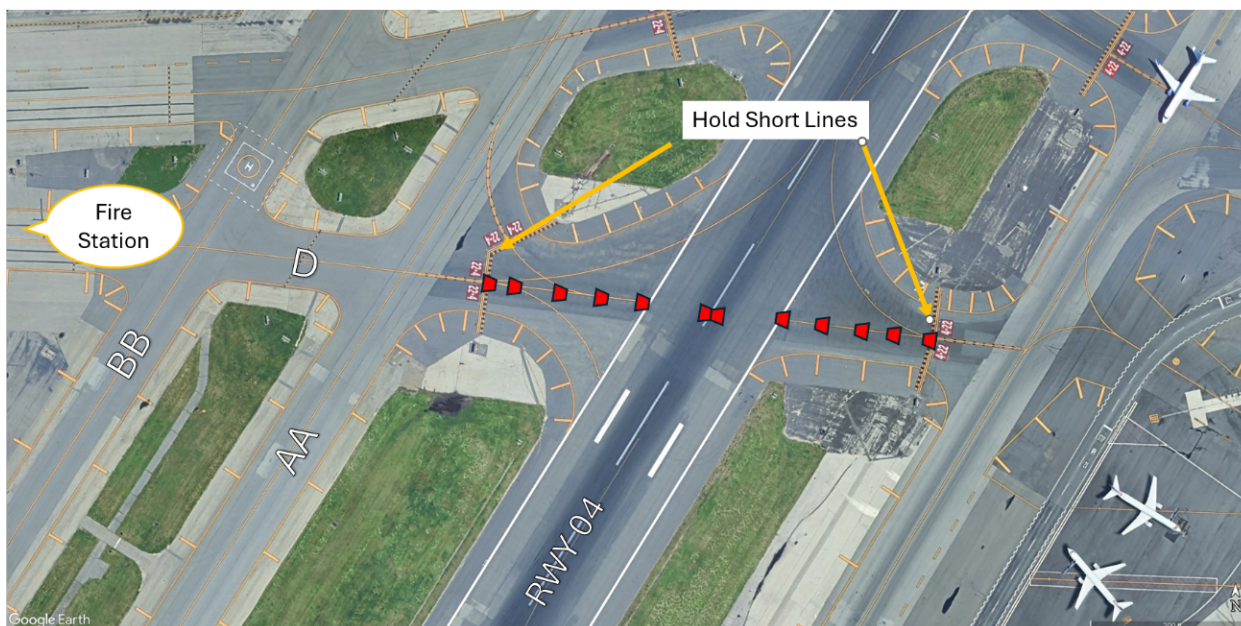
The airport was one of the 20 airports equipped with a runway status light (RWSL) system, which provides airplane and ground vehicle operators with a real time warning about potential conflicts at runway/taxiway intersections. It includes RELs installed at most taxiway/runway intersections, which illuminate red to warn taxiway traffic whenever runway traffic is approaching the intersection. A depiction of these lights is shown for the intersection of taxiway D and runway 4 in figure 8. These lights are located along taxiway centerlines from the hold short line(s) to the runway edge(s) with another on the runway centerline. They are focused away from the runway, such that when activated, they are visible to traffic on the taxiway approaching the runway.

**Figure 8.** Depiction of runway entrance lights (RELs) for the intersection of taxiway D and runway 4.

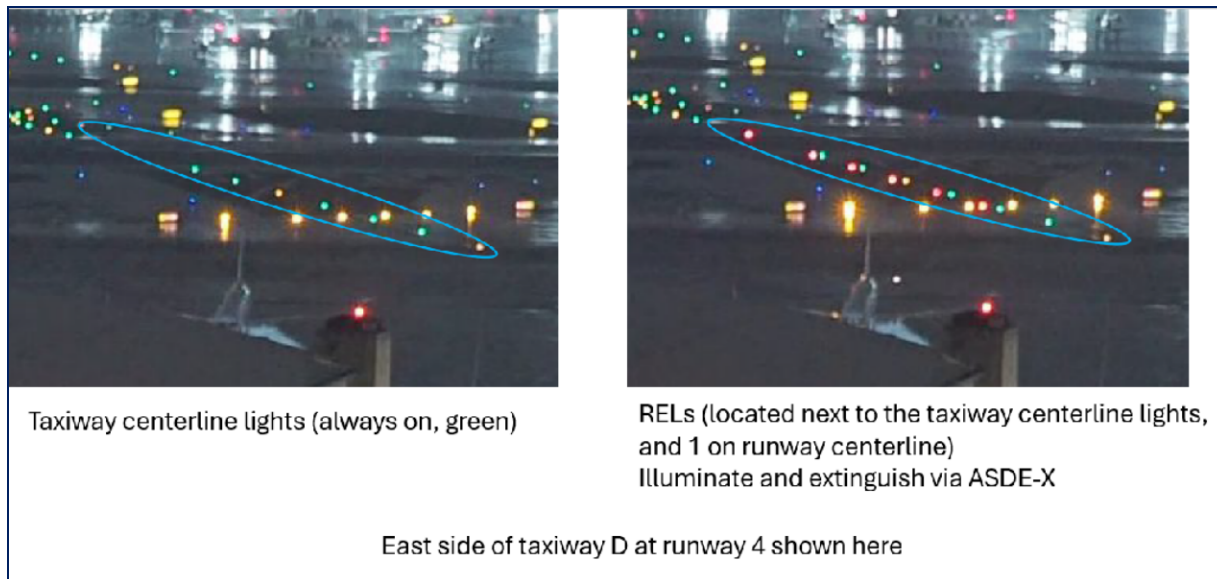
A review of airport surveillance video recordings revealed that the RELs illuminated for the arrival of the accident airplane, as Truck 1 and company were stationary in the vicinity of the taxiway AA and taxiway D intersection, about 300 ft away from the runway 4 hold short line on taxiway D. The RELs on taxiway D remained illuminated until about the time Truck 1 reached the (near) edge of runway, when they extinguished, about 3 seconds prior to the collision. Figure 9 shows surveillance video of the RELs both when off and when activated, on taxiway D east of runway 4.

**Figure 9.** Left image RELs OFF - Right image RELs ON. (Source: Port Authority of New York and New Jersey)
