October 2, 2025

MIR-25-36

# Hull Failure and Implosion of Submersible *Titan*

North Atlantic Ocean

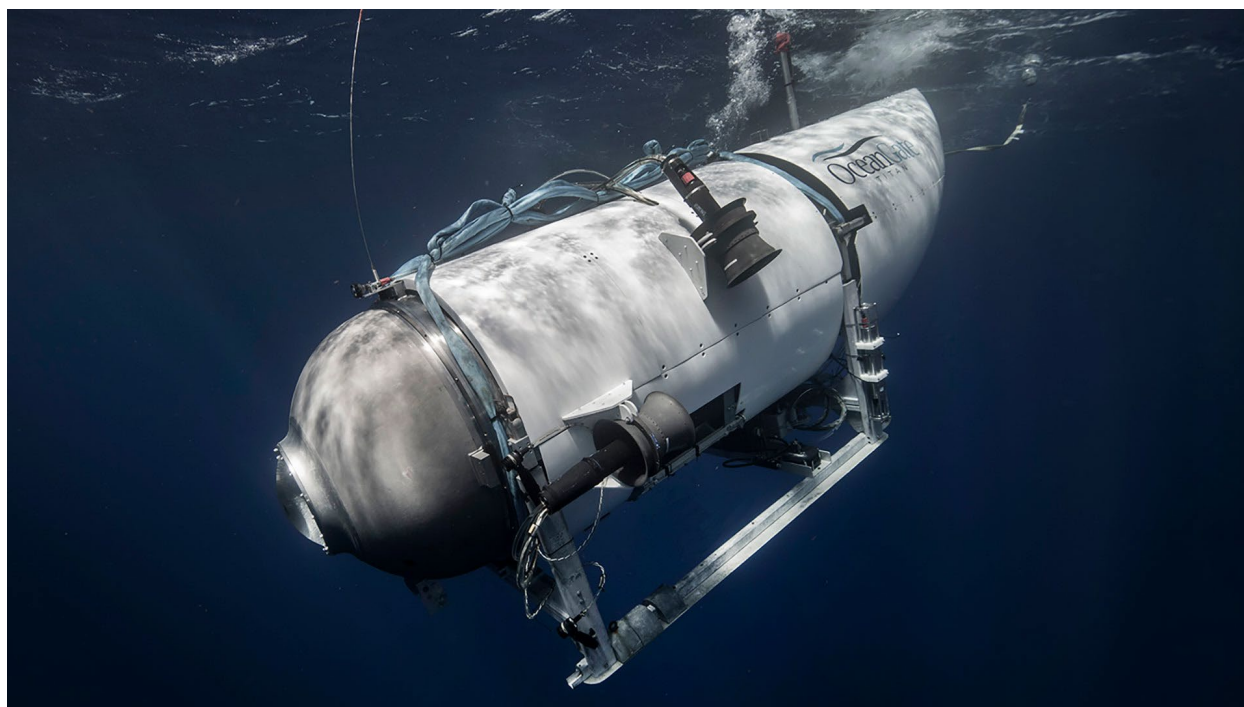
On June 18, 2023, about 1047 local time, while diving near the wreck of the ocean liner *Titanic* in the North Atlantic Ocean, about 372 miles southeast of St. John's, Newfoundland and Labrador, Canada, the submersible *Titan*'s pressure hull failed, and the vessel imploded (see figure 1).<sup>1</sup> All five persons on board the vessel died. The *Titan* was a total loss; according to a 2023 customs declaration, the submersible's value, combined with its launch and recovery system, was estimated at \$5.6 million CAD (about \$4.2 million USD).<sup>2</sup>

**Figure 1.** Submersible *Titan* descending on unknown date. (Source: OceanGate)

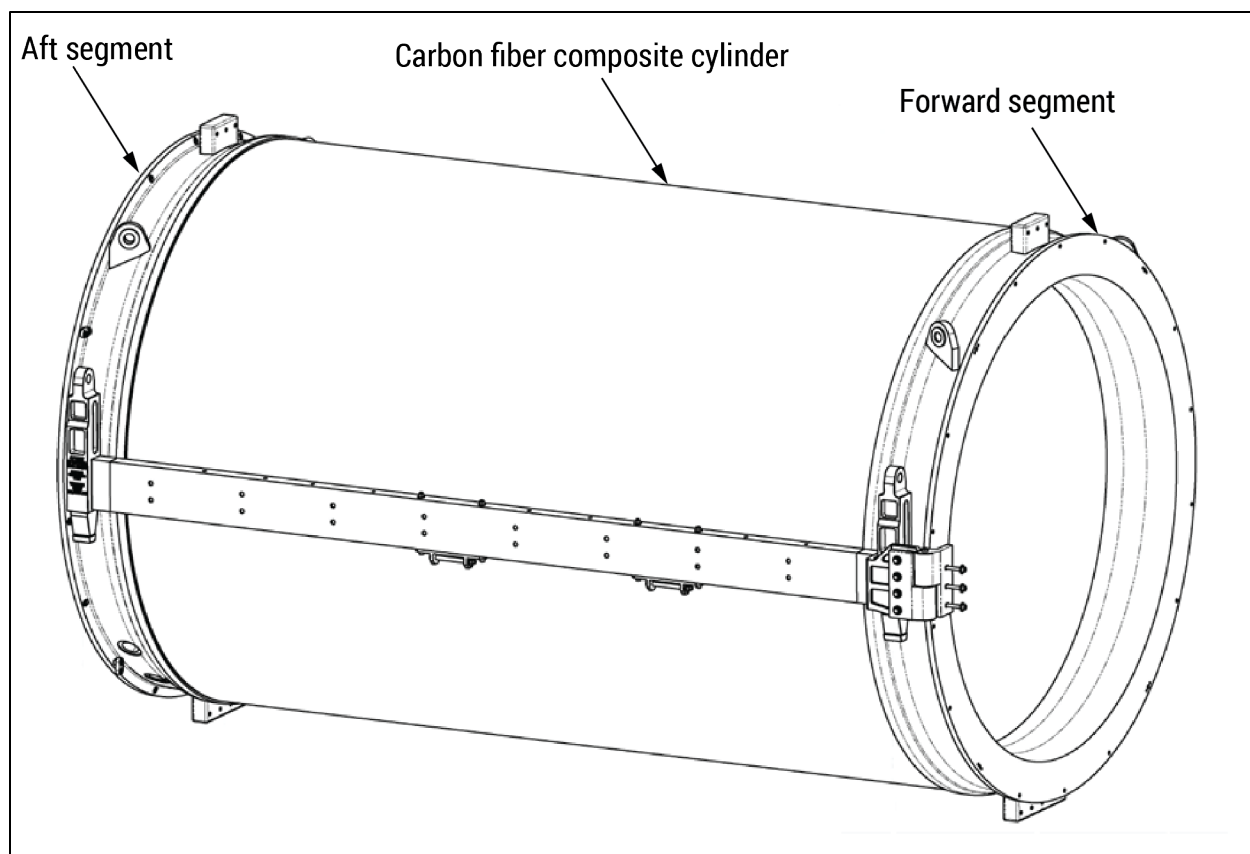
The pressure vessel was constructed in 2020 and consisted of a thick-walled, carbon fiber-based composite cylinder fitted at each end with a titanium ring (segment) that was capped with a titanium dome (hemisphere) (see section 1.3.3 for more details about the vessel's construction) (see figure 2).<sup>5</sup> The titanium segments were glued to the cylinder, and the titanium domes were bolted to the segments.

**Figure 2.** Pressure vessel composite cylinder and titanium end segments. Titanium spherical domes (not shown) were bolted to the segments at either end. (Background source: OceanGate)

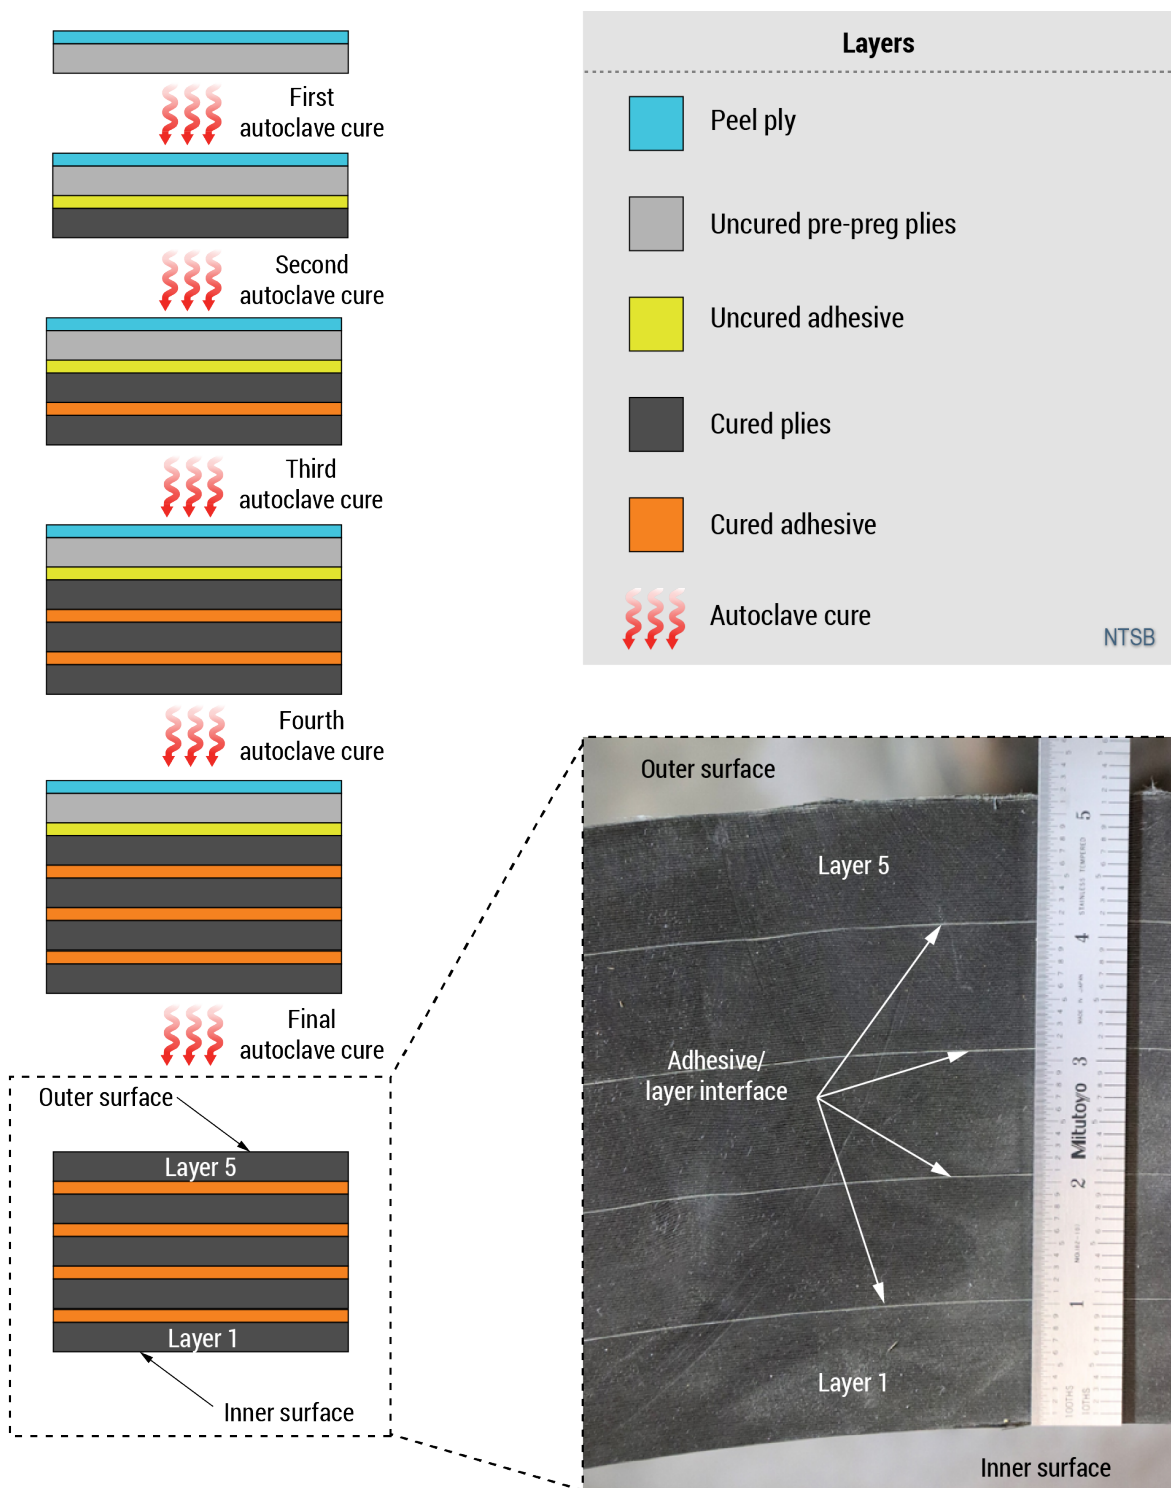
The v2 full-scale pressure vessel cylinder was manufactured from rolls of pre-preg carbon fiber—again by winding 0.5-inch-wide tows onto a cylindrical carbon steel mandrel by automatic fiber placement—and constructed as a series of five co-bonded, nominally 1-inch-thick composite layers. Each layer consisted of 133 pre-preg plies applied to the mandrel following a predetermined build ply sequence. The sequence consisted of two cylindrical plies followed by one longitudinal ply. The sequence was repeated until all 133 plies had been applied. According to data published by the fiber manufacturer, this would have resulted in a nominal 0.9975-inch-thick layer. A removable layer (peel ply) was applied on top of the pre-preg, and the assembly was cured in an autoclave (autoclave curing was performed at Janicki Industries, Inc. in Hamilton, Washington).<sup>26</sup> After autoclave curing, the peel ply was removed and an adhesive film was applied to the cylinder surface. The build ply sequence was then repeated and the assembly was autoclaved until the cylinder was (nominally) 5 inches thick (see figure 7).

**Figure 7.** Representation of co-bonding process used to manufacture the *Titan*'s hull. Inset is a cross-section of the actual *Titan* cylinder wall showing the co-bonded layered structure.

Our examination determined that there was porosity between plies, voids in the adhesive used to join the co-bonded layers, and a preexisting disbondment between the first and second co-bonded layers. Wrinkles and waviness in the carbon fiber were observed on the trimmed end pieces, and multiple wrinkles in the carbon fiber had been leveled flush with the outer surface using a grinding tool during the manufacturing process (see figure 16).
